SURVEY REPORT

Yacht PELICAN **14 January 2016**

INSPECTION & SURVEY OF SAILING VESSEL

REPORT REFERENCE: EAYS-16-02

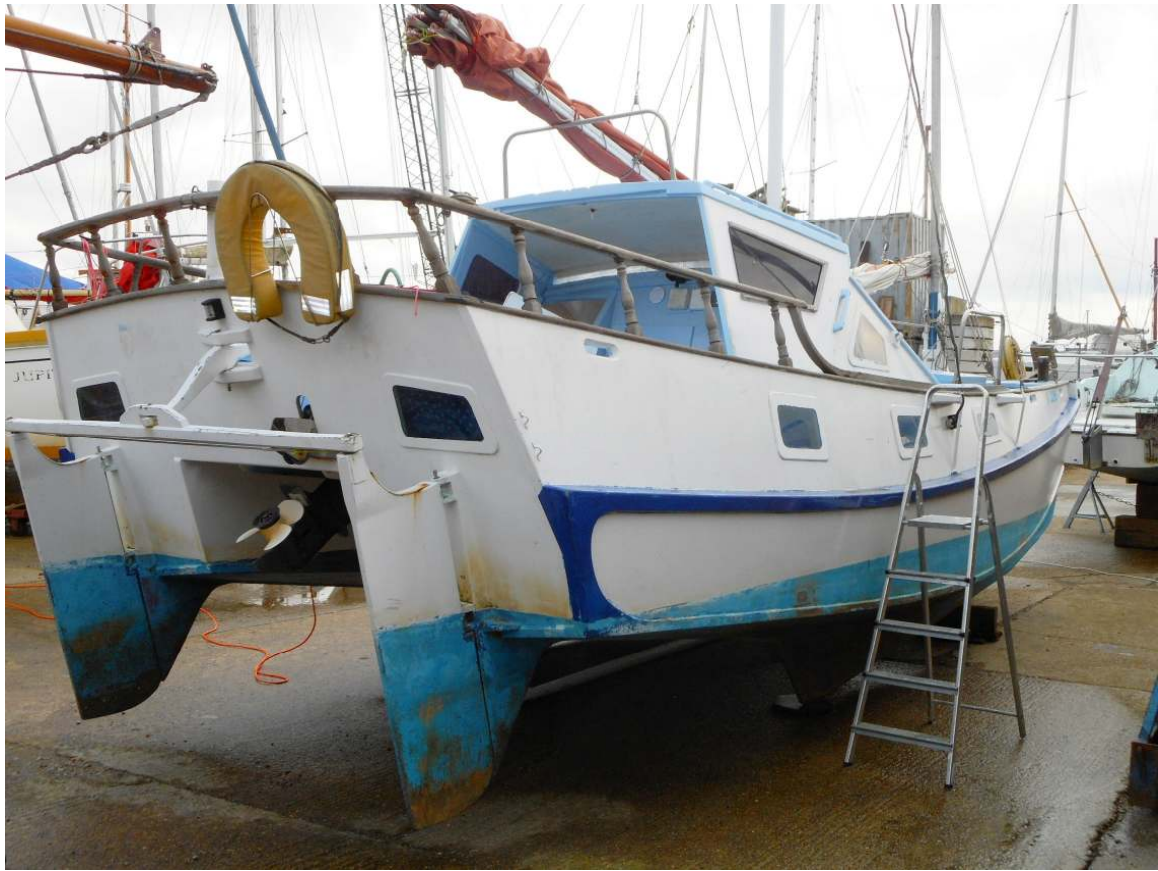
1.1 General. The lines were fair, with no signs of distortion due to hogging, sagging or wracking, as may be seen in **Fig 2** (below).

Fig 2. General view of vessel ashore.

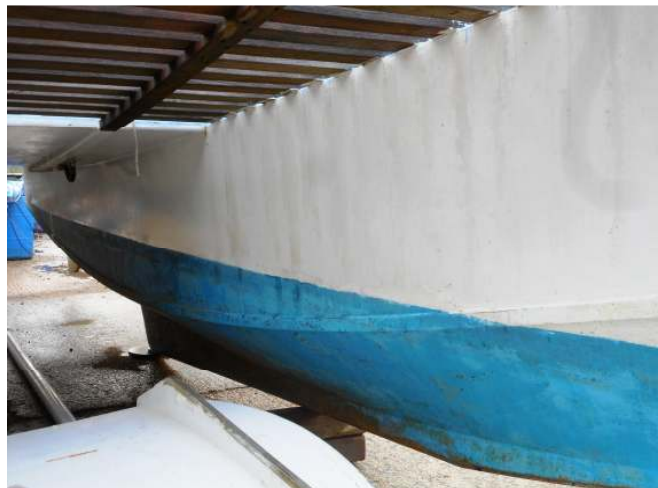
Fig 3. Inboard face of port hull.

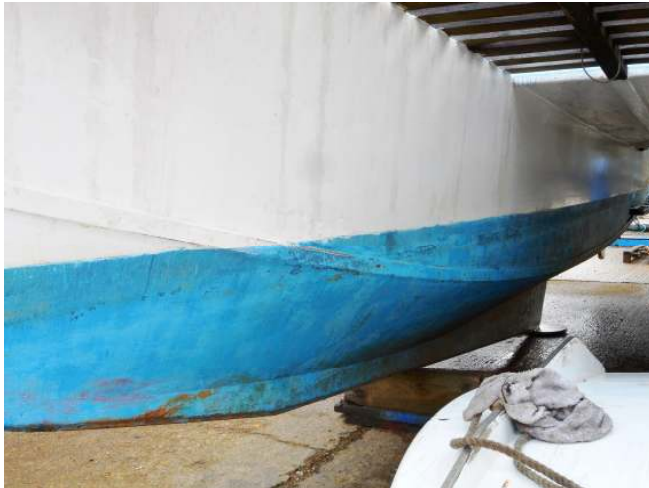
Chainplates for bowsprit bobstays were mounted at the waterline on each bow, as seen in **Fig 4** (below, left): there was no sign of strain or looseness, and they could be re-used in the future if necessary.

Fig 4 (below). Inboard face of starboard hull.

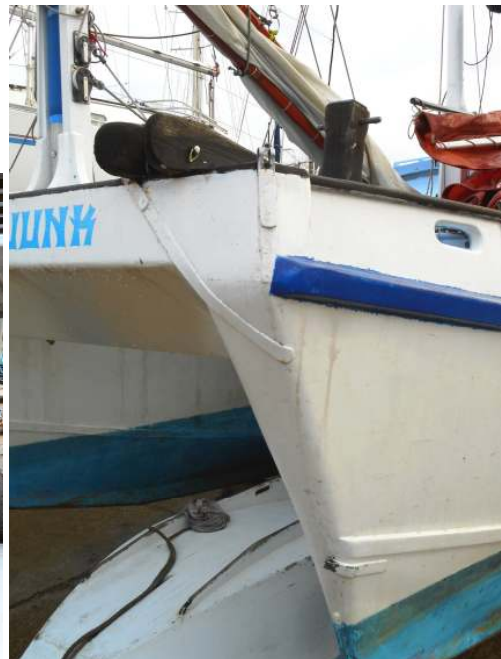
Fig 5 (right). Port bow.

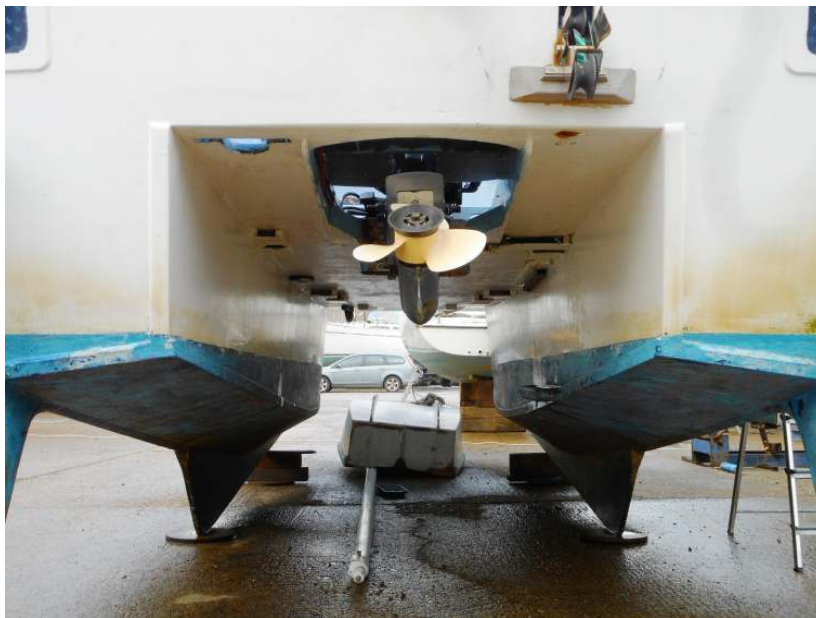
Fig 6. Transom and gap between hulls.

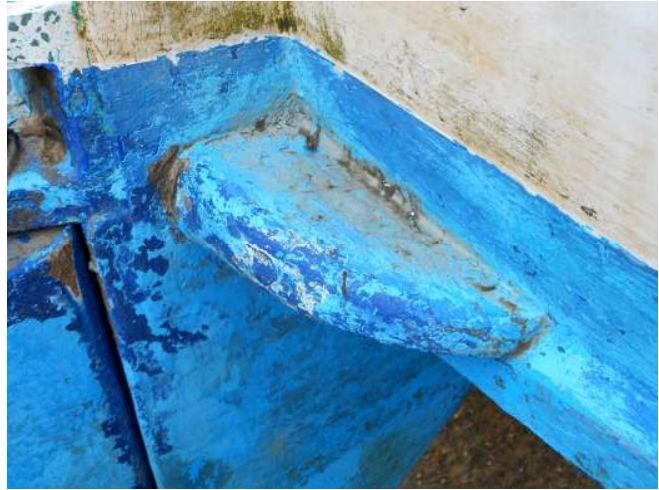
The skegs / sternposts were both in good condition, with no sign of deterioration or decay in any part. It was noted that each sternpost was reinforced on the outboard side by a timber quadrant, to spread the rudder strains across the transom, as seen in **Fig 7** (right): there were no signs of strain or movement.

Fig 7. Detail of root of skeg / sternpost, showing reinforcing quadrant.

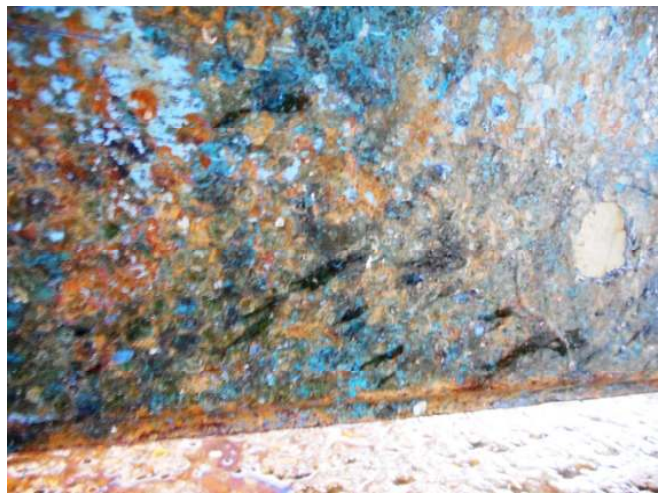
The keels were securely bolted to the bottom of the hog, and were in generally good condition. They were each protected on the underside by a steel strap: surface corrosion was in evidence, but there was no sign of movement or undue wear and tear. However, some gribble damage was noted on the inboard faces towards the aft end, as seen in **Fig 8** (right). Some slight localised softness was noted in some of the indentations, but these only extended a few millimetres into the timber, and are not of structural concern at this time. The joints between the hulls and the keels were closely examined, and there was no evidence of movement. There was no sign of rust to indicate corrosion of the keelbolts, and no evidence of leakage to the interior.

Fig 8. Detail of bottom of keel, showing evidence of minor worm / gribble damage.

1.4 Given the expected wear and tear from grounding / drying out, the keels should be fully re-preserved using several coats of hard wearing antifouling or tar varnish: this would prevent any bare wood showing through, which may result in further gribble attack (Cat C – Structural).

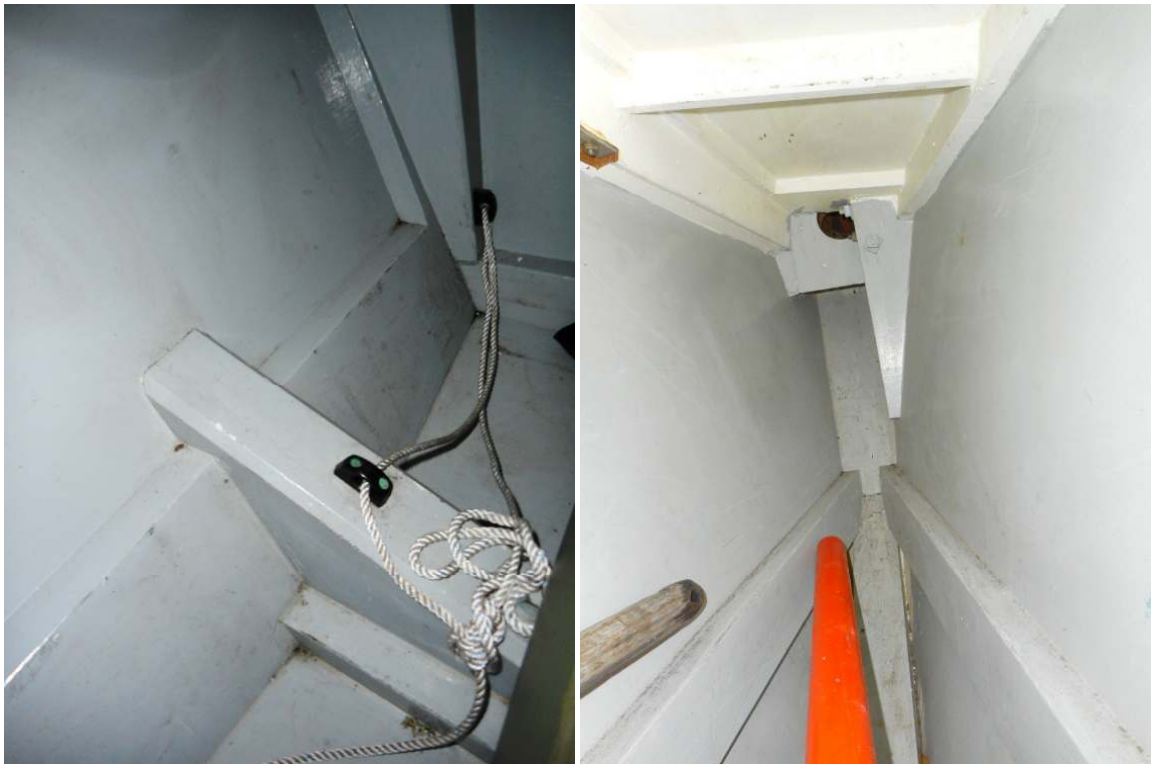
Figs 9-10. Construction inside starboard transom (left) and port bow (right).

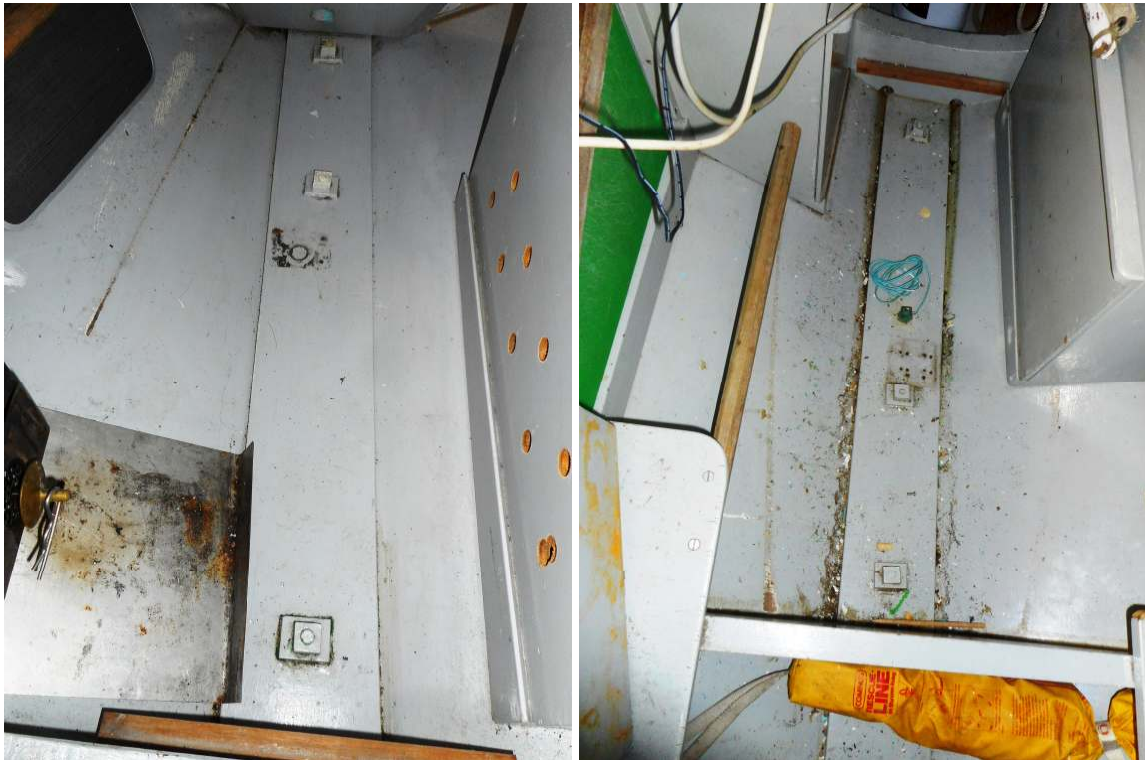
Figs 11-12. Hog and lower bilge in port hull (left), and starboard hull (right).

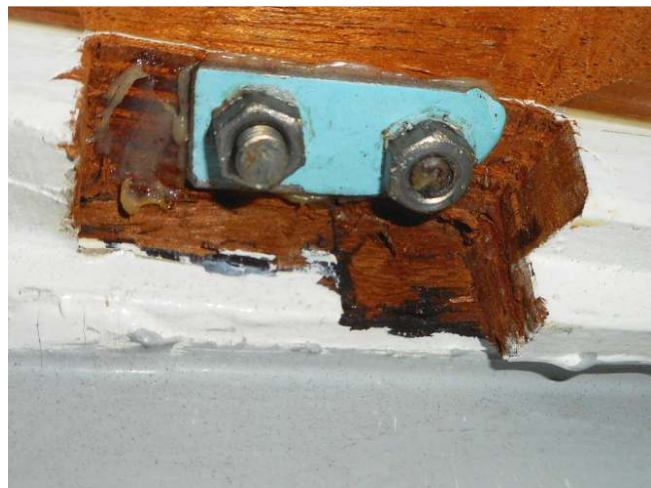
Fig 13. Detail of fitting inside beam shelf.

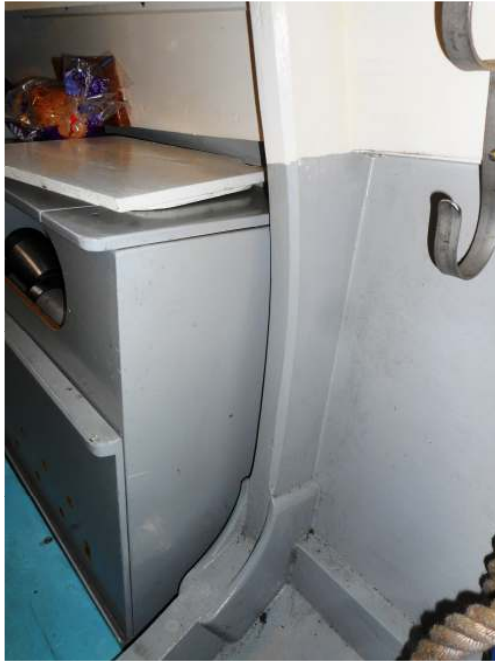
Fig 14 (left). Example of frame in port hull.

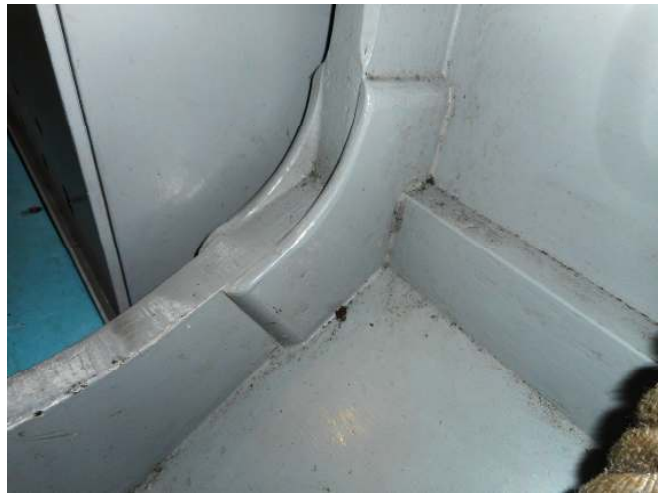
Fig 15 (below). Detail of reinforcement over chine.

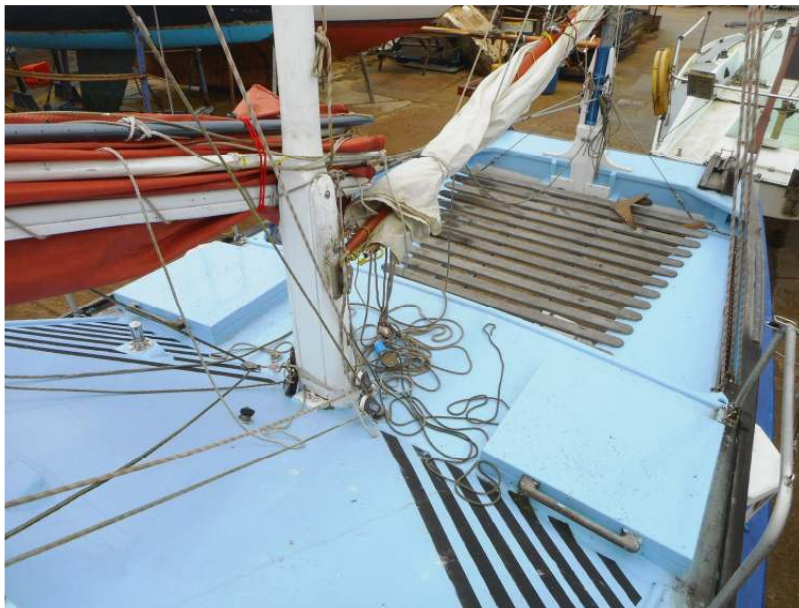
Fig 16. General view of foredeck and coachroof.

The foredeck was of close-spaced slats of 20mm (¾") teak, as may be seen in *Fig 16* (above). These were in good condition for their age, though well weathered: there

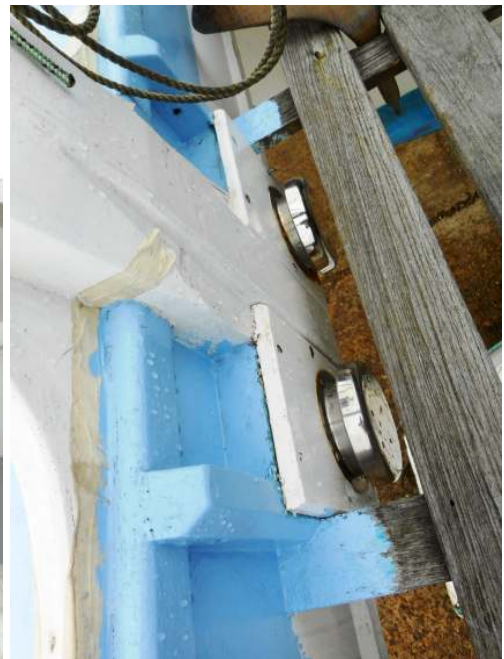
Fig 18 (right). Detail of forward crossbeam, with base of tabernacle and vents.

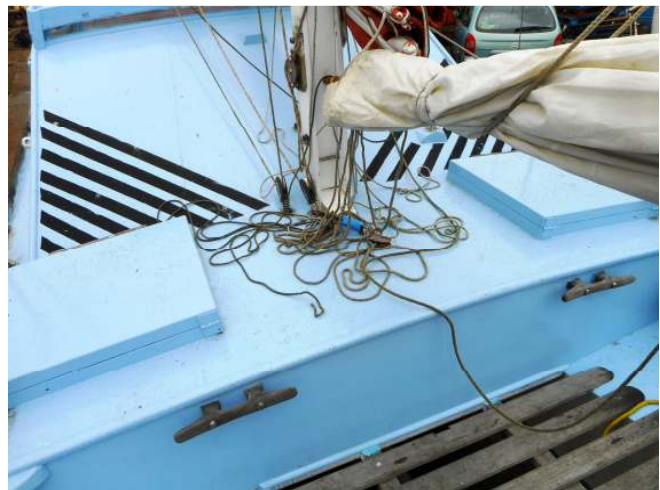
Fig 19. Forward end of coachroof.

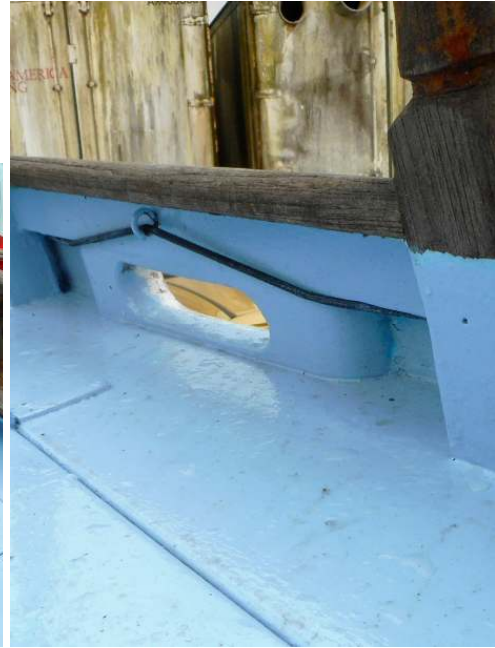
Fig 21 (right). Freeing port above cockpit seat.

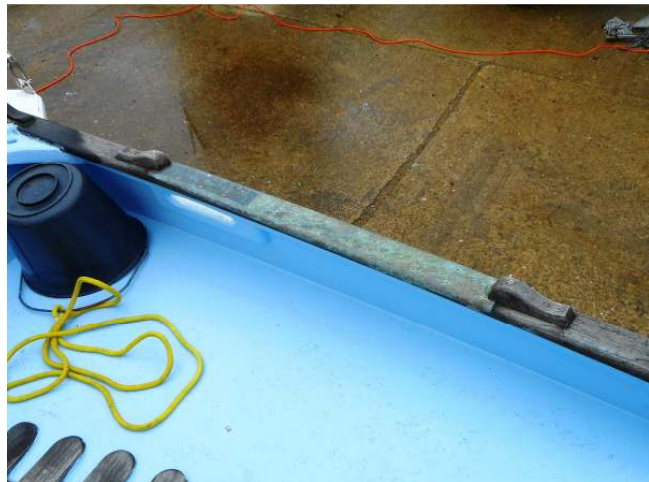
Fig 22. Chafing plate on capping rail.

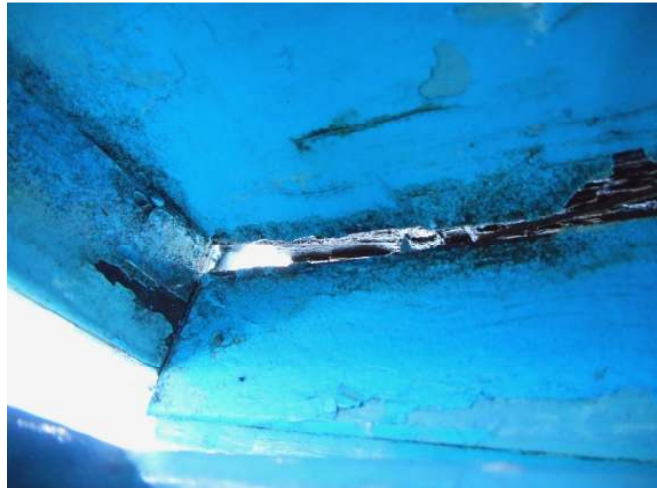
The aft hatches hinged on their outboard sides, recessing flush with the cockpit seating when closed, and secured from inside using a retaining rope and cleat. A waterway was fitted under the lip, but dampness had caused softness and deterioration in the timberwork of the starboard aft hatch, as seen in **Fig 23** (right).

Fig 23. Deterioration in starboard aft hatch.

5.2 *Repair starboard aft hatch (Cat B – Structural).*

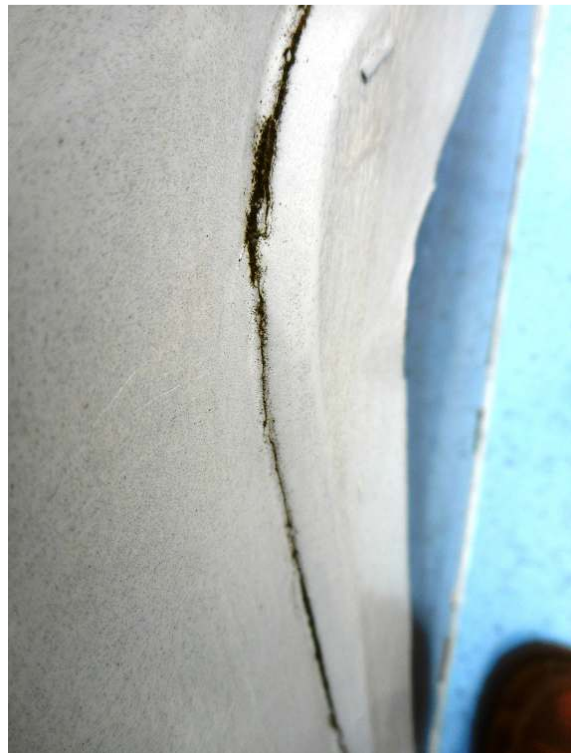
Fig 24. Slight movement at coachroof window.

5.3 *The crack in the paint around the periphery of the starboard coachroof window should be thoroughly cleaned. Once fully dried, a penetrating resin (such as the proprietary “Creeping Crack Cure”) may be administered. This spreads by capillary action, and will penetrate before setting. Several doses may be needed before full watertightness is achieved: it is best to wait approx 30 mins between doses, and continue until no more resin can enter the joint (Cat C – Structural).*

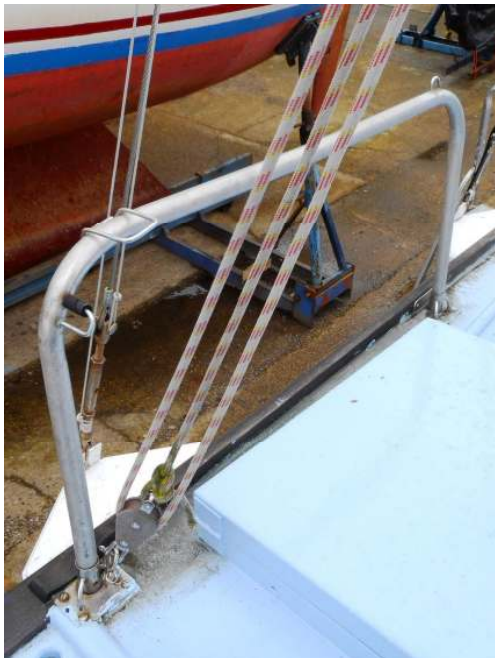
Fig 25 (left). Grab bar, starboard side.

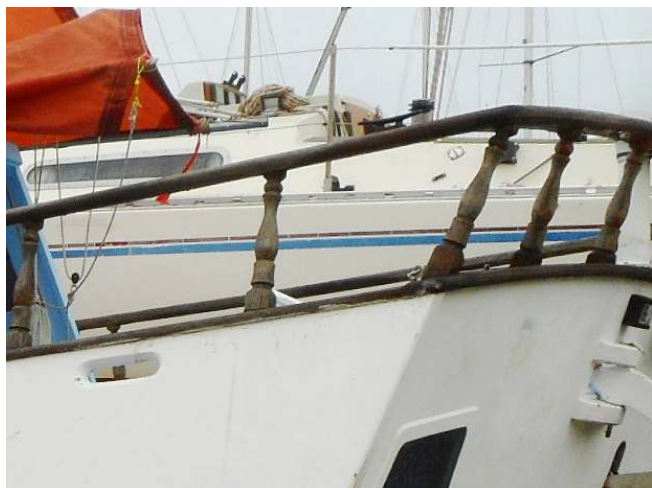
A teak taffrail was mounted on turned stanchions fitted around the cockpit. This was sound, but in weathered condition. There were no signs of deterioration around the stanchion bases, but the structure would generally benefit from oiling, to prevent further weathering.

Fig 26 (below). Taffrail.

6.1 Oil timber taffrail, to prevent deterioration (Cat C – Structural).

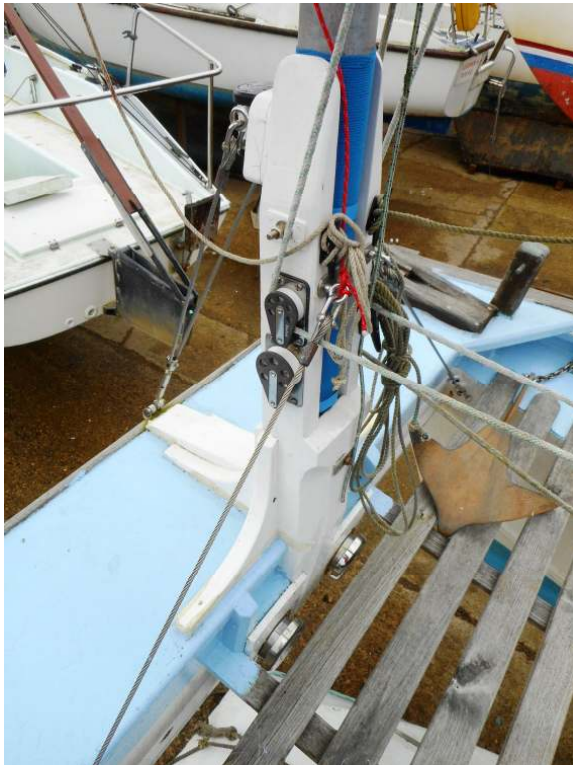
Fig 27 (above). Foremast tabernacle.

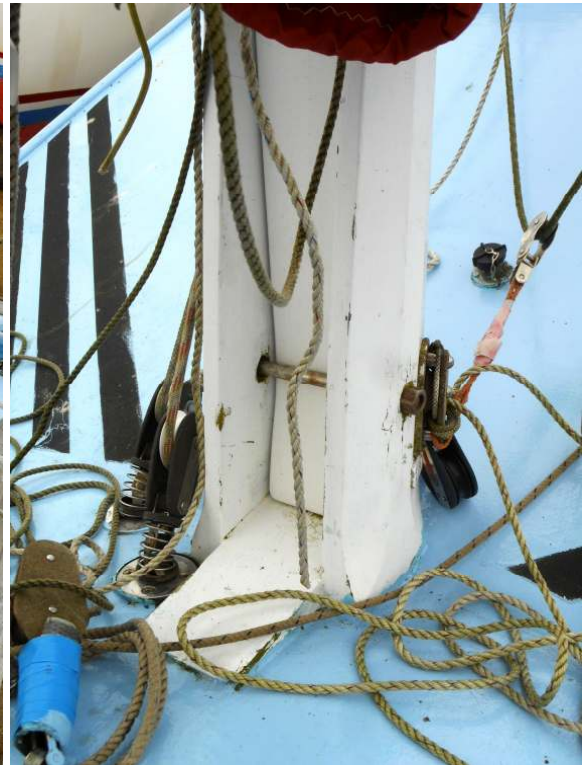
Fig 28 (above, right). Mainmast tabernacle.

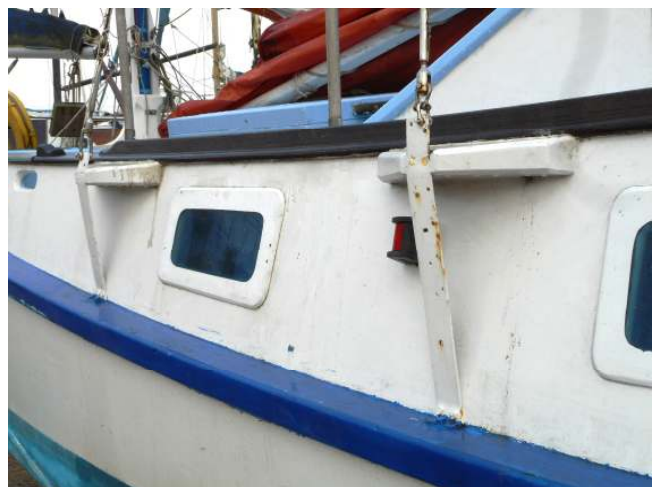
Fig 29 (right). Port chainplates for mainmast.

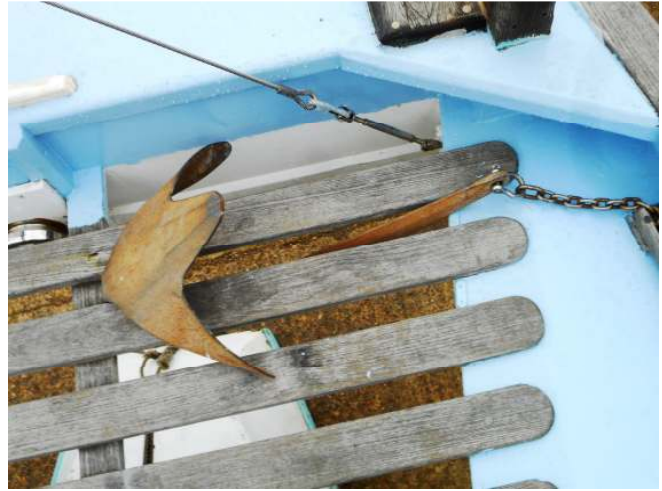
Fig 30. Bower anchor.

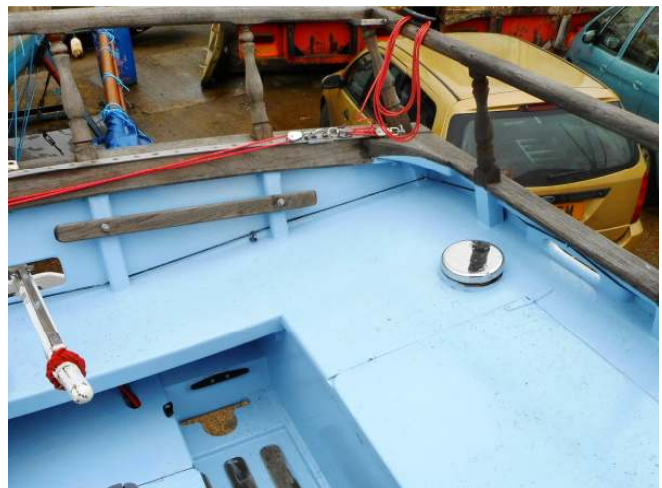
Fig 31. Cleat and fairlead, port quarter.

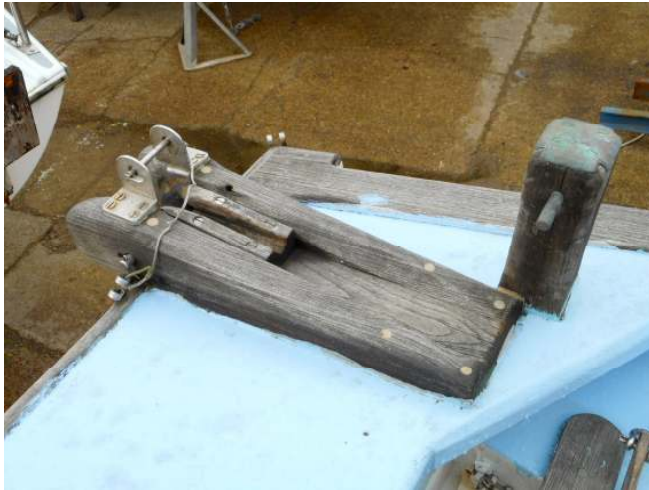
Fig 32 (left). Anchor fairlead and samson post.

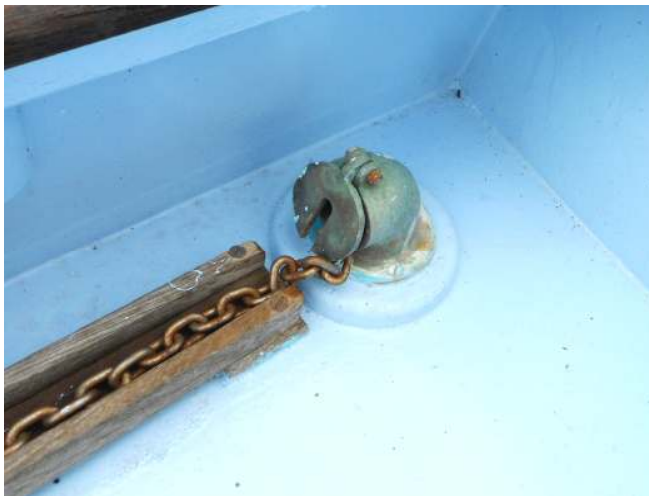
Fig 33 (below, left). Cable channel and navel pipe.

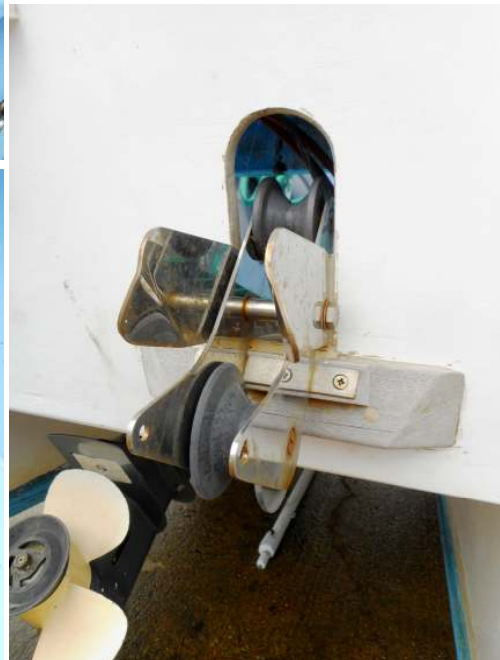
Fig 34 (below). Aft anchor fairlead.

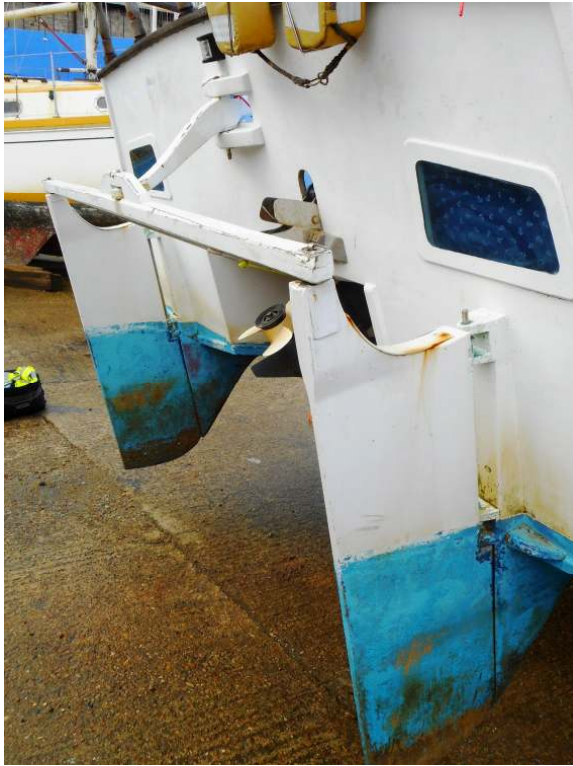
Fig 35. General view of rudders.

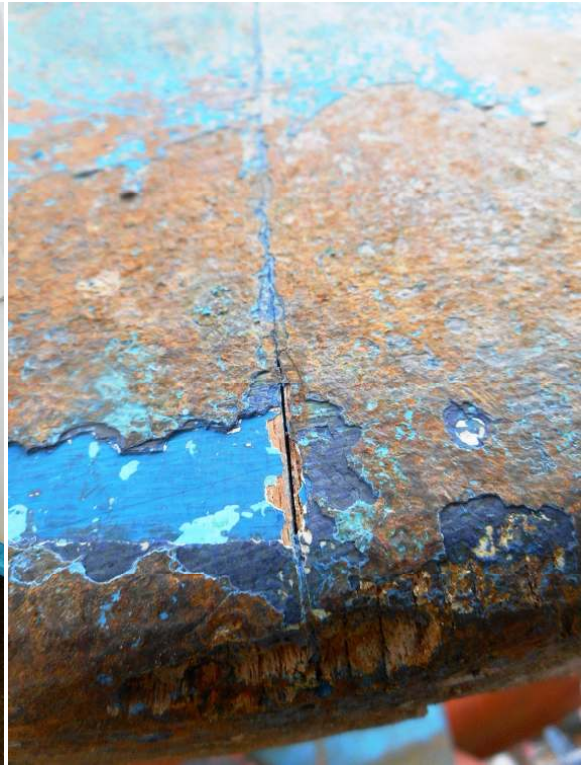
Fig 36. Detail of open seam on port rudder blade.

8.2 Blades and stocks. The rudder blades were each formed of three layers of timber, tapered to shape. They were tested by hammer-sounding and spike testing, and found to be hard and sound, with no areas of softness or decay on the accessible surfaces. There were no cracks or shakes visible through the protective coatings, except that a joint was clearly visible at the bottom of the outboard face of the port rudder, as seen in **Fig 36** (above, right). No softness or deterioration was found in the vicinity but if left untreated, it may allow borers to penetrate the timber.

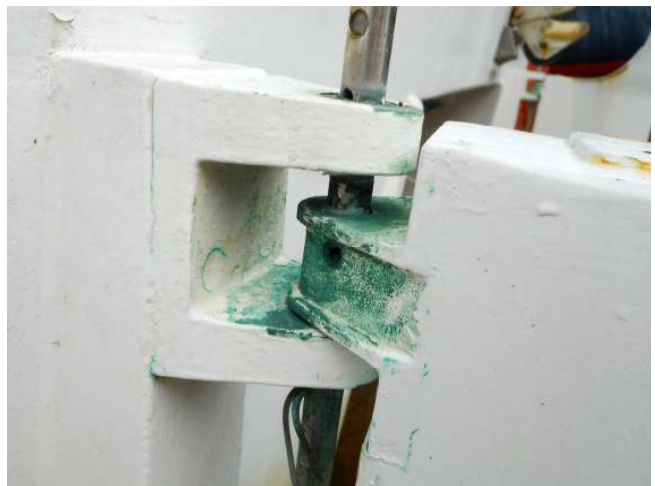
All parts were in good condition, with no sign of strain in the fastenings or the surrounding structure. No undue looseness was observed in the lower bearings, but approx 3mm ($\frac{1}{8}$ ") play was found on both upper bearings. This was

Fig 37. Upper bearing on port rudder.

not of structural concern, but they would benefit from re-bushing.

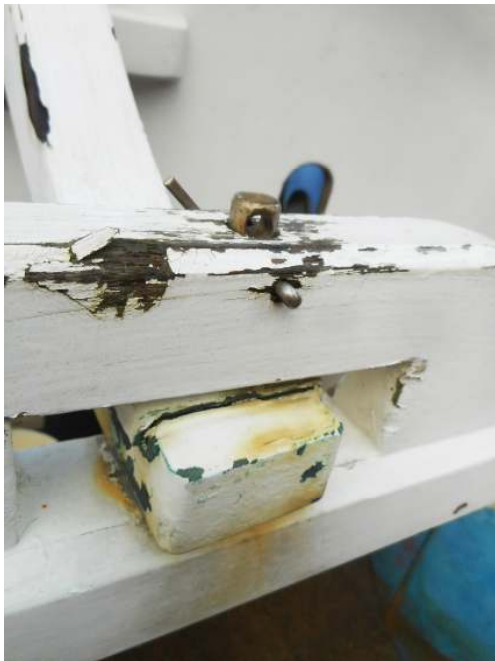
8.4 Rudder linkage. The rudders were moved by a laminated crossbar securely fastened to bearings in the top of the rudder blades. The crossbar was fitted with a hood bracket on the centreline, to which was fitted a laminated tiller. All securing bolts and washers were in good condition, with no sign of looseness or undue play, but there were signs of moisture penetration of the timber around the hood bracket, as seen in **Fig 38** (below, left)

Fig 38 (left). Centre of crossbar, showing damp timber by hood bracket.

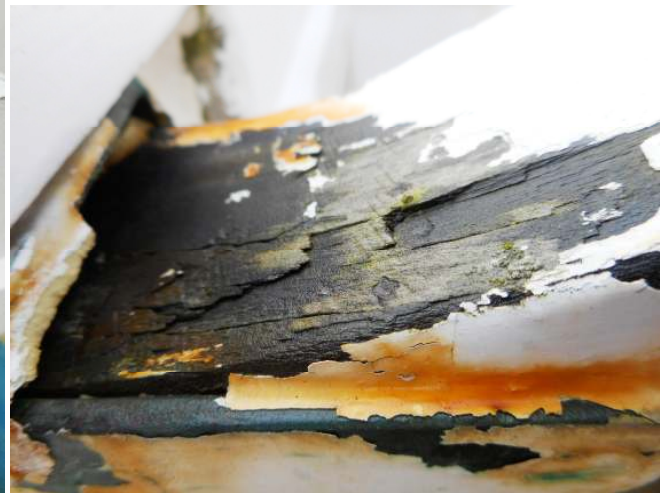
As the crossbar was at the aft edge of the rudders, the tiller was fitted with a separate bearing, in the same plane as the rudder bearings. As a result, it was under much less strain than would be found in a conventional rudder arrangement. The tiller was in fairly good condition, though some moisture ingress and slight softness was noted adjacent to the hood bracket, as seen in **Fig 39** (below, right).

Fig 39 (below). Dampness in tiller by hood bracket.

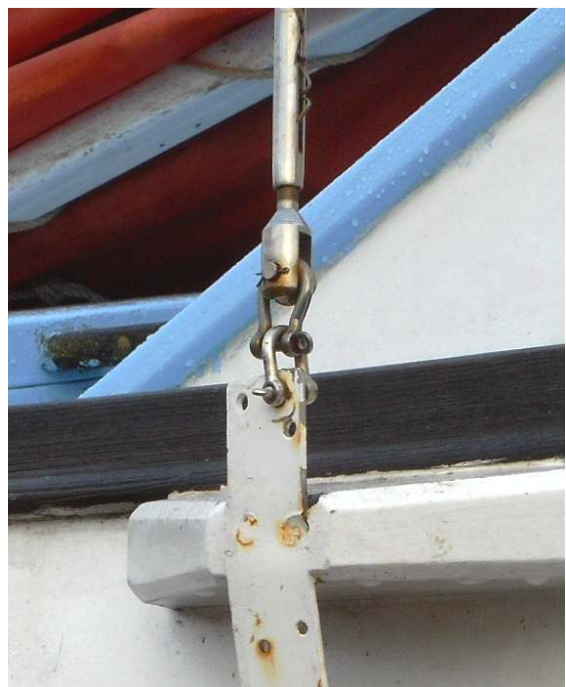
Fig 40. Detail of bottlescrew attachment.

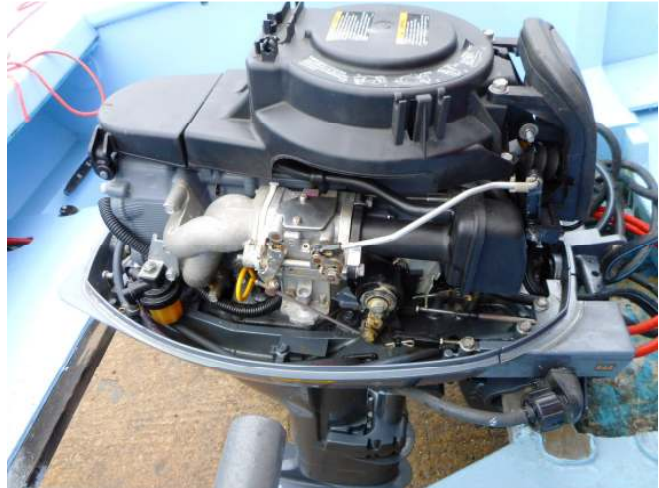
Fig 41. Motor, with cowling removed.

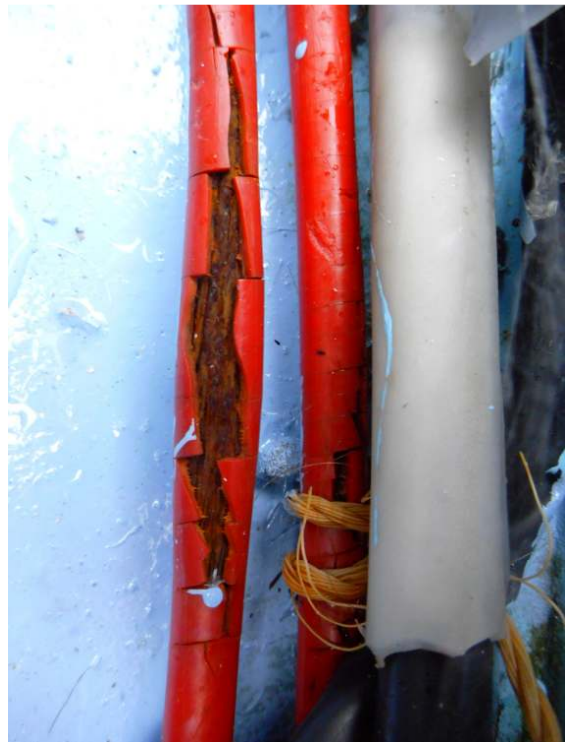
The motor was controlled by Morse cables from a single lever control by the helm position. Though functional, they were noted to be corroded, with splits in the sheathing, as seen in **Fig 42** (right), and may seize at any time.

Fig 42. Corrosion in throttle and gear control cables.

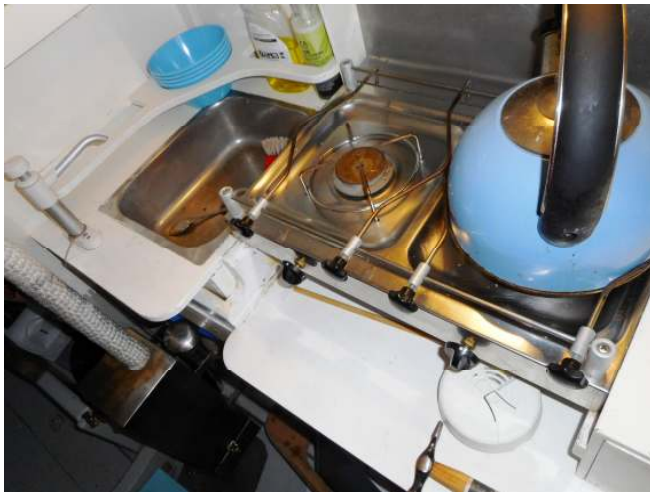
Fig 43 (below). Galley, with cooker.

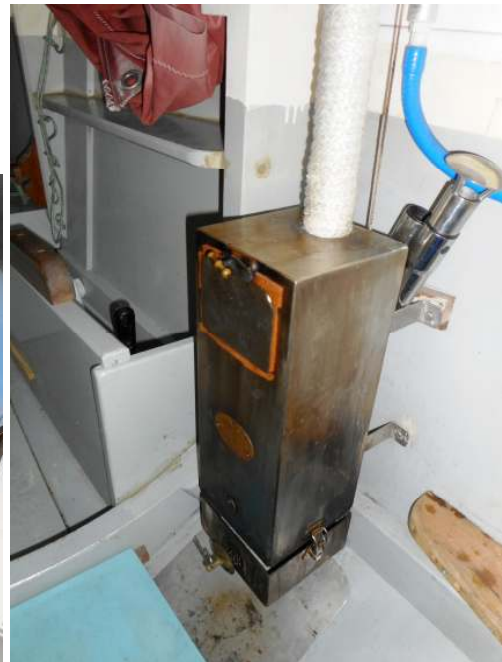
Fig 44 (right). Heater.

11.7 Heater. A small solid-fuel heating stove was fitted in the port hull, just forward of the galley. It was in good condition and well installed, with a stainless steel plate underneath, to prevent head damage. The chimney was well-insulated (preventing inadvertent scorching), and there were no signs of leakage where it passed through the cabin top.

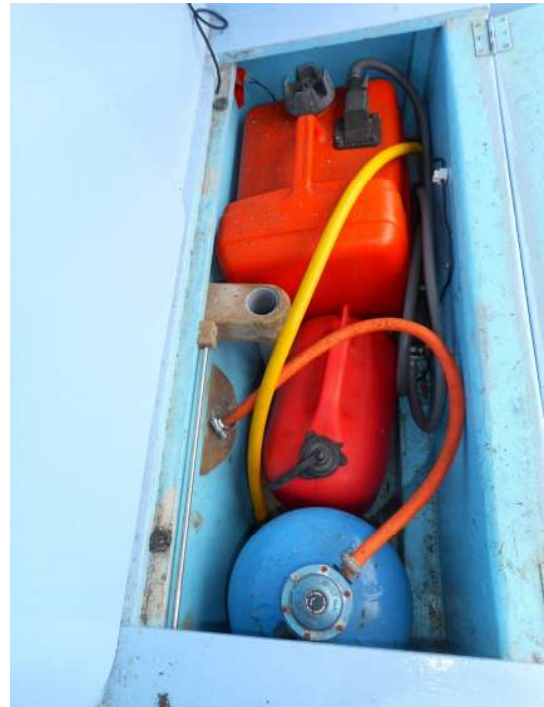
Fig 45. Gas stowage.
