## Wrinkles

..an illustrated summer letter to the Yahoo JR group ...

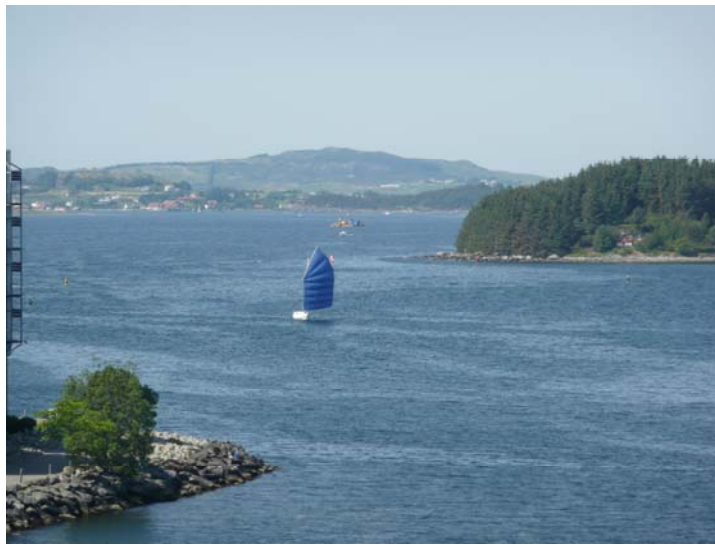
Approaching Stavanger from north

Photo above: Edward has spotted us and caught us with his long lens. Running before, the sail sets with a minimum of wrinkles as there is not much down-haul from the sheets.

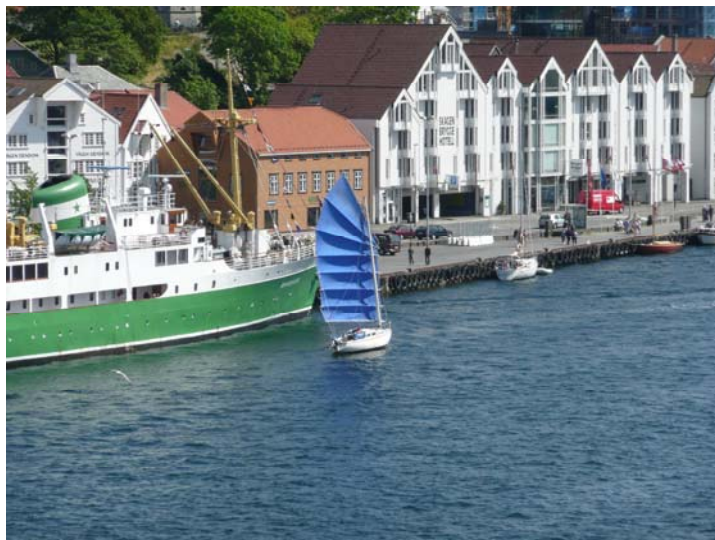
Running into the inner harbour

On this photo (prev. page) the sail has been sheeted in, both to slow the boat down and to prepare for a quick and easy retreat. We don't haul in for max close-hauled sailing as we want good acceleration out of the short tacks.

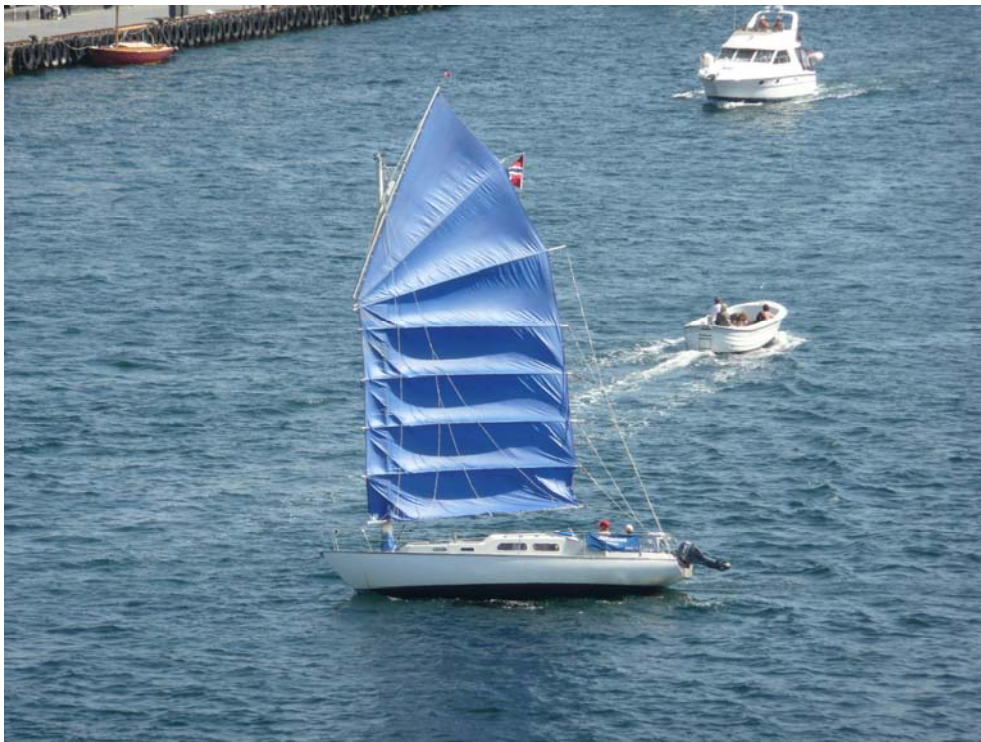
Coming out of the tack, the flag indicating a stalled sail

In the turbulence among houses and big ships, aiming for perfect setting is no use. Still, the junk rig must be one of the handiest rigs for such close manoeuvrings with no staysails to blind you or catch you a-back. Johanna's good coasting ability helps to cross turbulent or calm spots. Honestly, I can't remember missing a tack with that boat.

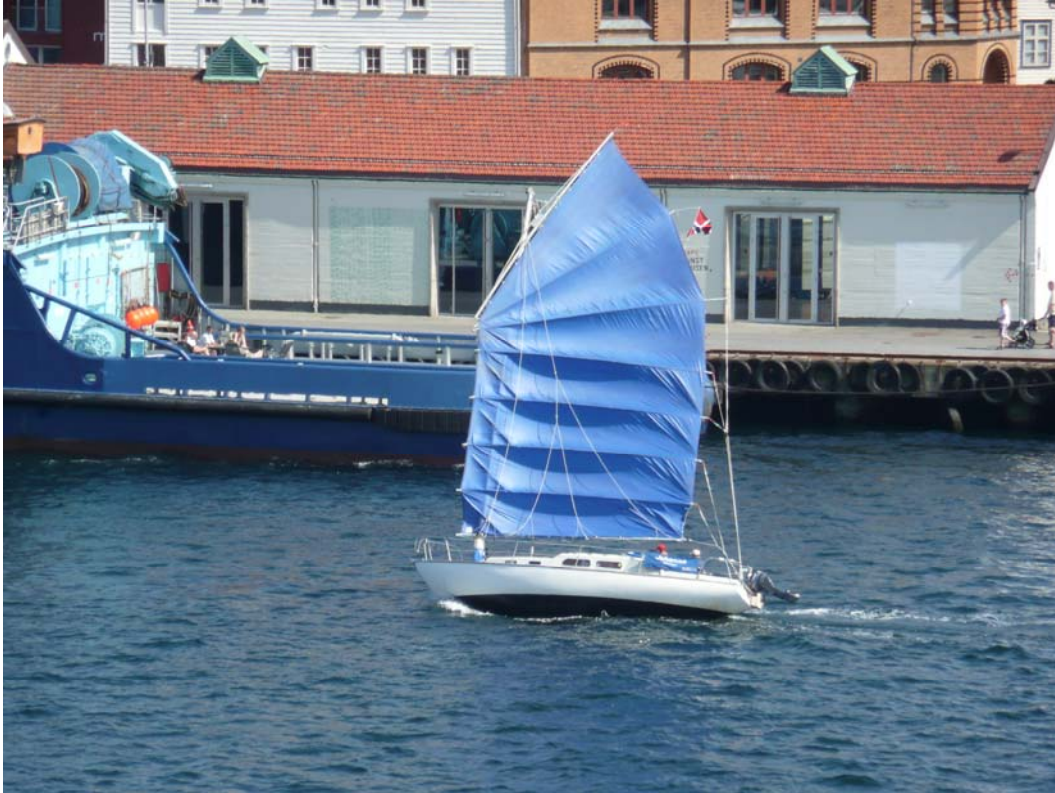
Let's get out of here...

- The luff is nice and taut on all but the lowest panel. The mast is on the short side so getting the last panel taut is a bit difficult. As the sail is being reefed, the “new “, lower panels get a bit slack luff too since I don't bother with down-hauls. Still, by leaving the reefed batten hanging just a bit above the boom, it will help stretching the luff. I see no reason for installing down-hauls. Johanna still only has the four basic running lines: Halyard, sheet, luff h. parrel and yard h. parrel.

- The diagonal Hong Kong parrels at the mast can be seen cutting into the sail at this tack. Not much to do about it. They are there to keep the whole batten panels from developing those big diagonal wrinkles that pull out the camber. The camber has a higher priority than most other details.

- At the aft end of the four lower panels, with the sheets pulling hard, some rather bad wrinkles have shown up. I think the webbing type bolt-rope should take much of the blame here; it is simply a bit too elastic. The easiest cure is probably to hand-stitch on a rope type bolt-rope to the port side of the leech. Still, I wonder if the wrinkles do that much harm: This far aft on the sail, the boundary layer must have grown quite thick, so will hardly notice the rough surface. **What do you think?**

- The leech of the lowest panel is very slack (.. this indicates that the wind have reached F4...). This actually used to cause a rather annoying flutter. The reason for this phenomenon is that as the wind picks up, the short sheet span of panel 7 doesn't provide enough down-haul on the boom (The lazy-jacks are nice and slack). My cure has been to hand-stitch on a 5mm thick shock-chord to the leech of panel 7 at about 20 cm intervals. The shock-chord is stretched about 5cm at each interval. As the wind picks up and the boom lifts, the shock-chord pulls in the slack. Not neat, but at least the sail keeps quiet. I have done the same to panel 4 as the same problem shows up here when the sail is being reefed to 4 panels.

- The flag and the telltales at the leech indicates that the upper part is about to go out of stalled mode, but the lower 3 panels are still stalled (.. you have to trust me here; I can spot the telltales on the original hi-res photo...). The boat starts to lean over and pick up speed in the free wind.
- The outboard engine may look funny on such a big (29ft/3ton) boat, but I don't regret for a second that I fitted it instead of a new diesel at 3-4 times its price. I mostly use the engine in and out of harbours where it makes manoeuvring a child's play. Motoring on flat water, I have noted a consumption of 0.5litre/NM at 5.8knots. In harder winds and heavy swell; I just sail. That's why I stress the need for windward performance...

Finally, take a look at the waterline of Johanna. I guess we are heeling about 20-25°, but there is no sign of lifting the stern and diving the bow. The hull lines, with full bow sections and slim lines at the stern may not be the fastest, but it makes the boat easier to steer than most boats of her size. Closed-hauled at 30° heel, the tiller is still 2-finger light. Keep this in mind when you look for a boat. All too many skippers these days can be seen wrestling with the tiller of their modern, wide-sterned boats. I guess that's why many contemporary yachts, even down to 30ft length, have been fitted with helm steering....
