ONE OLD JUNK IS EVERYONE'S TREASURE:
THE EXCAVATION, ANALYSIS, AND INTERPRETATION OF A CHINESE
SHRIMP JUNK AT CHINA CAMP STATE PARK

A thesis submitted to
Sonoma State University
in partial fulfillment of the requirement for the degree of
MASTER OF ARTS
in
Cultural Resources Management

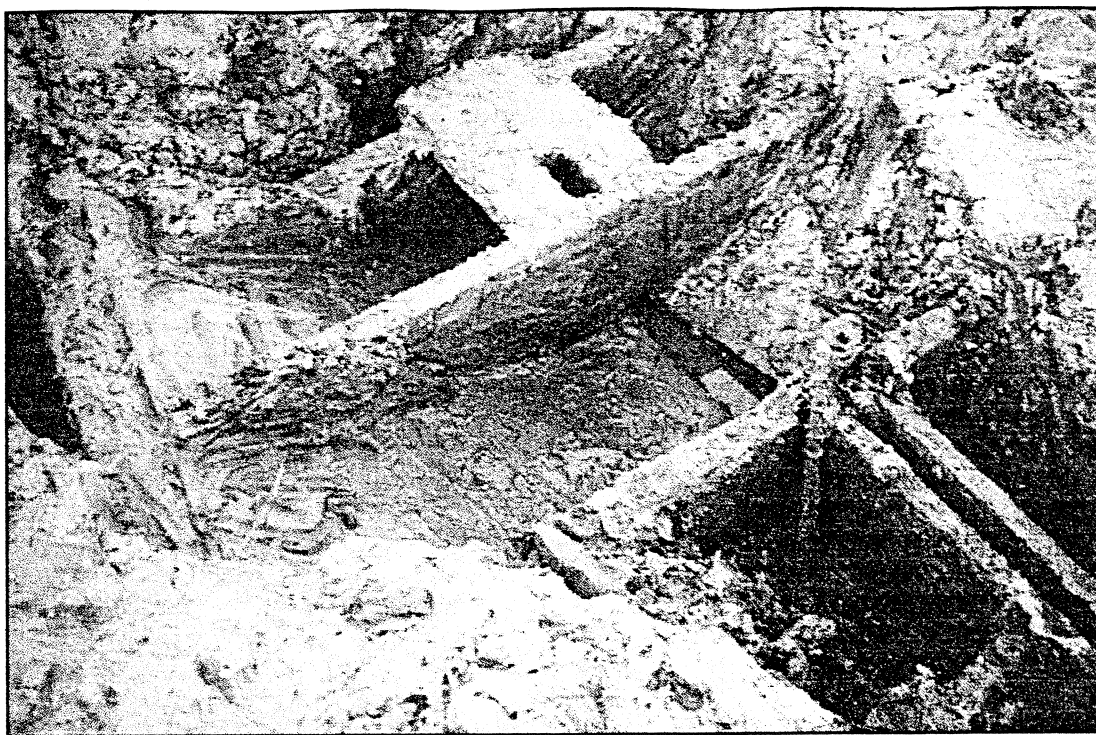
Figure 9. Excavation Position 2, showing the elevated forward step, daggerboard box, and starboard- side planking void. Outline of the void describes shape of scarf in garboard. Note also frame ends at stations 3 and 4. Paul Sanchez photograph.

The field team at Excavation Position 2 uncovered a number of its own surprises. The forward step was found to be notched into both the fifth and sixth floors, and elevated almost one foot above the keel (Figure 9). Furthermore, under the rectangular hole in the aft half of the step, the crew documented a series of grooves etched into the keel. The pattern of wear seemed to indicate that whatever had been inserted into the hole extended all the way down to the keel, and moved about while in position. Both garboards at Position 2 featured sloping edge scarfs that spanned the distance of two frames. These were unusual scarfs, differing as they did from the traditional Western scarfs, which commonly involve either the joining together of the sloped faces of two planks, or the use of a butt block as a backing piece at the place where the square-ends of the two planks meet. On the starboard side, the nib end of the aft half of the scarf was broken off and provided a good opportunity to gauge the thickness of both the keel and the planking there, as well as the bevel along the edge of the keel.

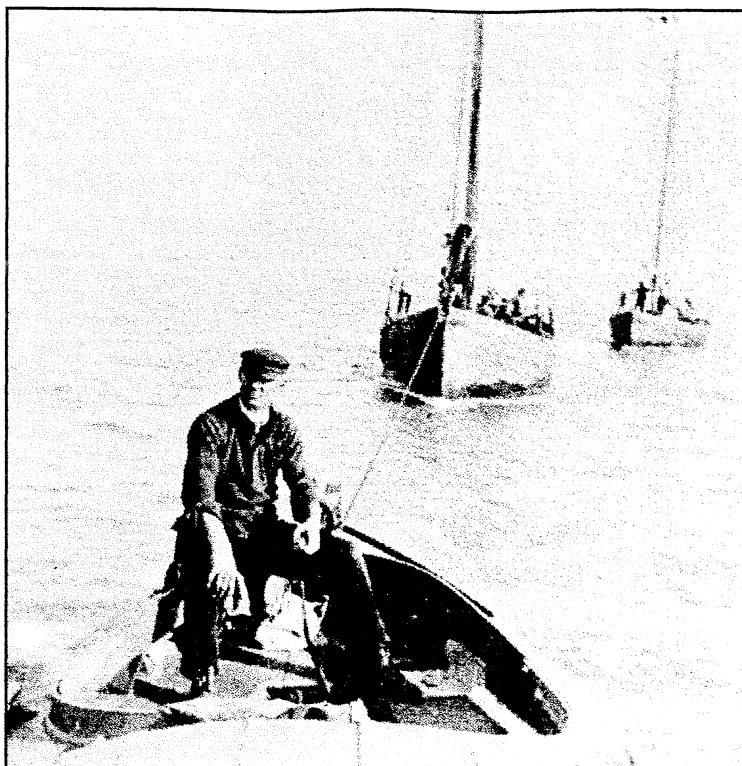
Figure 14. Deputies of California Fish Commission towing junks. This may be an image of either Scofield or Nidever steering the launch *Quinnat* during their October 1910 arrest of two shrimp fishing companies for possession of small fish. California DPR Photo Archives.

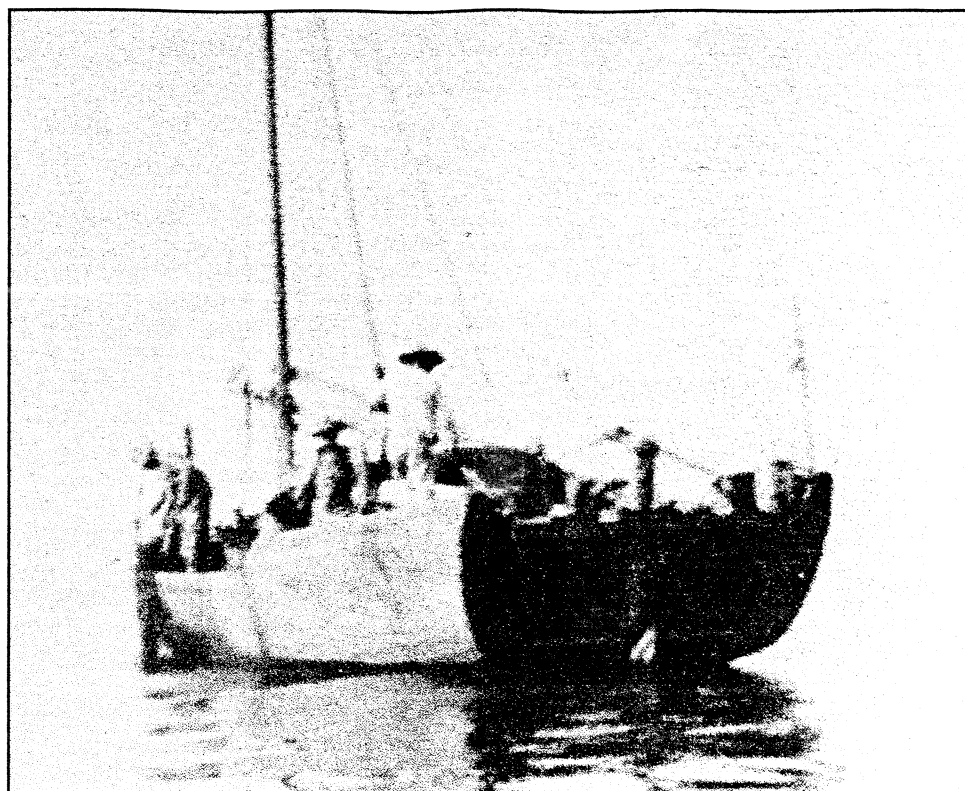
Figure 15. Stern view of shrimp junk, 1910. Though difficult to see, note cross timbers acting as gudgeons to hold the rudder post. Also note aft-most frames are aft of gudgeon shelf, and rake down to transom. Nidever Photograph, California DPR Archives.

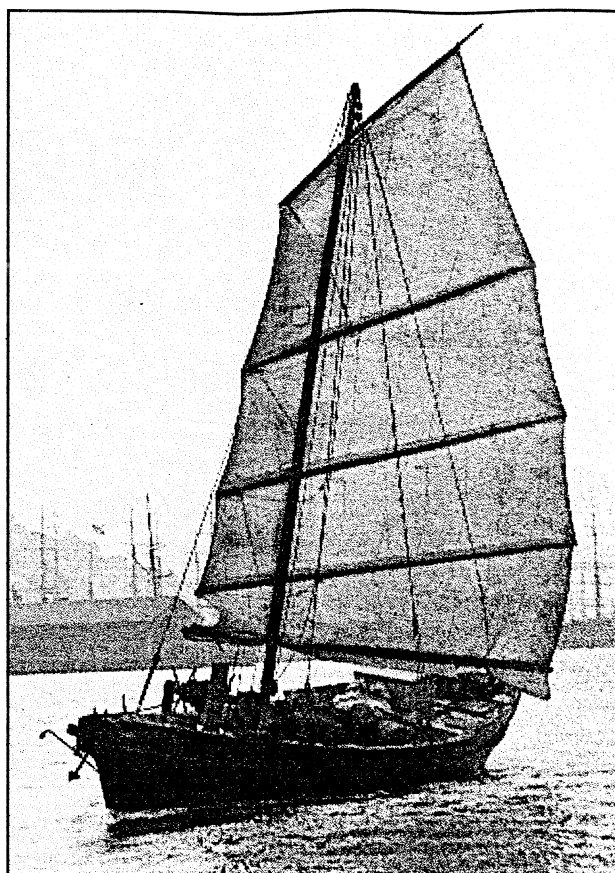
Figure 22. Shrimp Junk Sailing Along San Francisco Waterfront, 1887. Note small box-like structure aft, which could represent a rare cabin superstructure. Note also forward windlass, and daggerboard raised for downwind reach. Photo courtesy SF Maritime NHP.

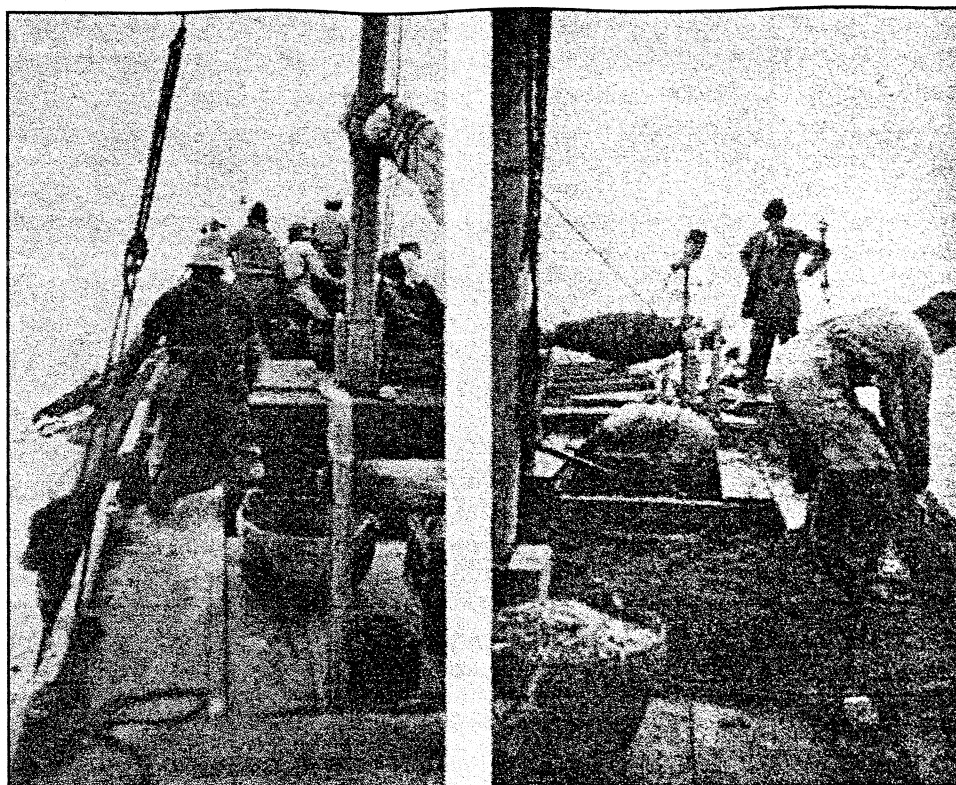
Figure 23. On Board Junk As Nets Are Being Pulled, 1910. The image on left was probably taken before the one on the right, as the latter features a windlass full of line, a hold full of nets and a basket full of shrimp. Note windlass in both images, as well as thole pins and deck planking. A California Fish Commission official, probably Scofield, observes shrimping operations. Nidever photograph, taken from Scofield's 1919 article in *California Fish and Game*.

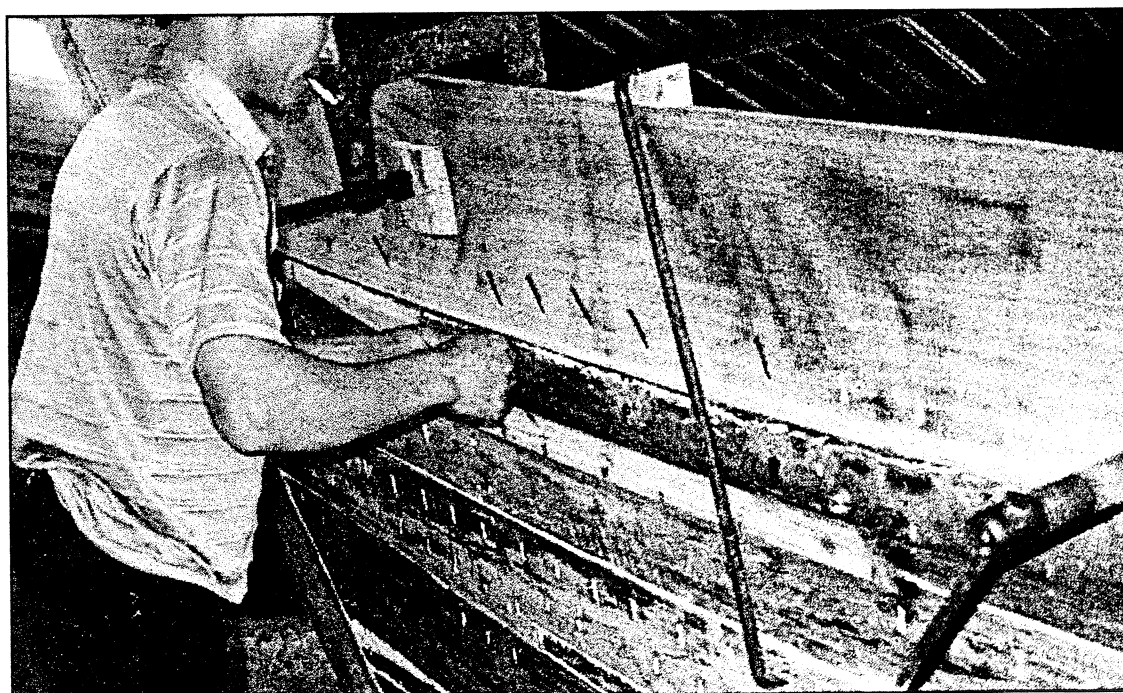
Figure 30 (below). Next, the builder sets tapered square nails into the notches. The nails are four inches long, headless, steel, and hand-forged in the shop. Note iron staple and wedge system used to edge set the plank into place.

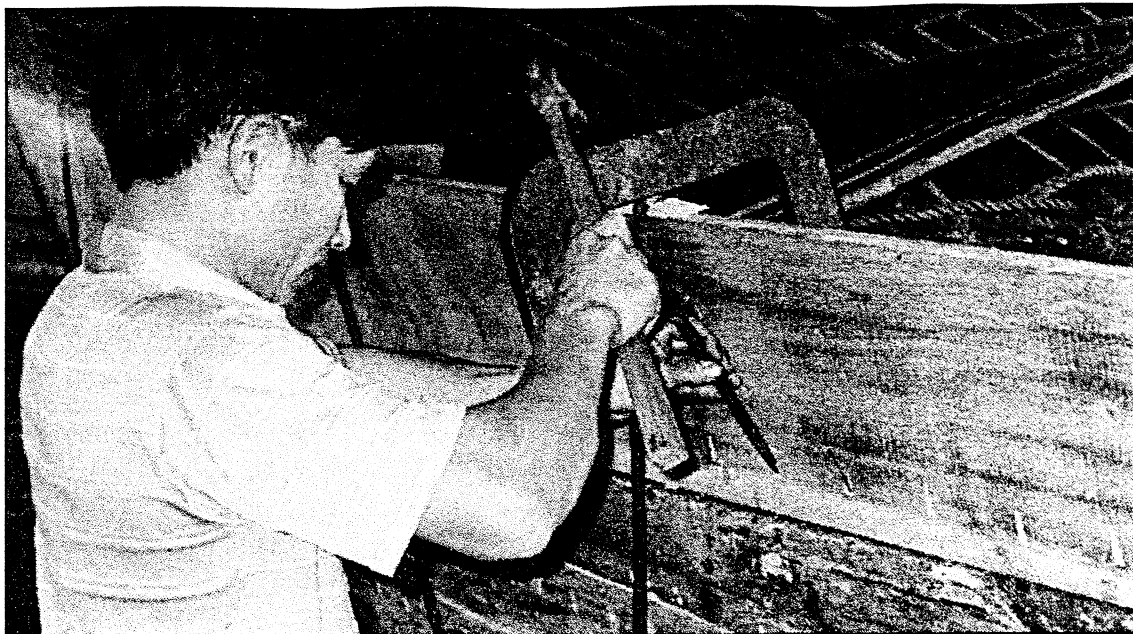
Figure 31 (above). The builder next drives home the nails using a long, triangular shaped nail set, until the nail ends just disappear into the wood of the triangular notch.

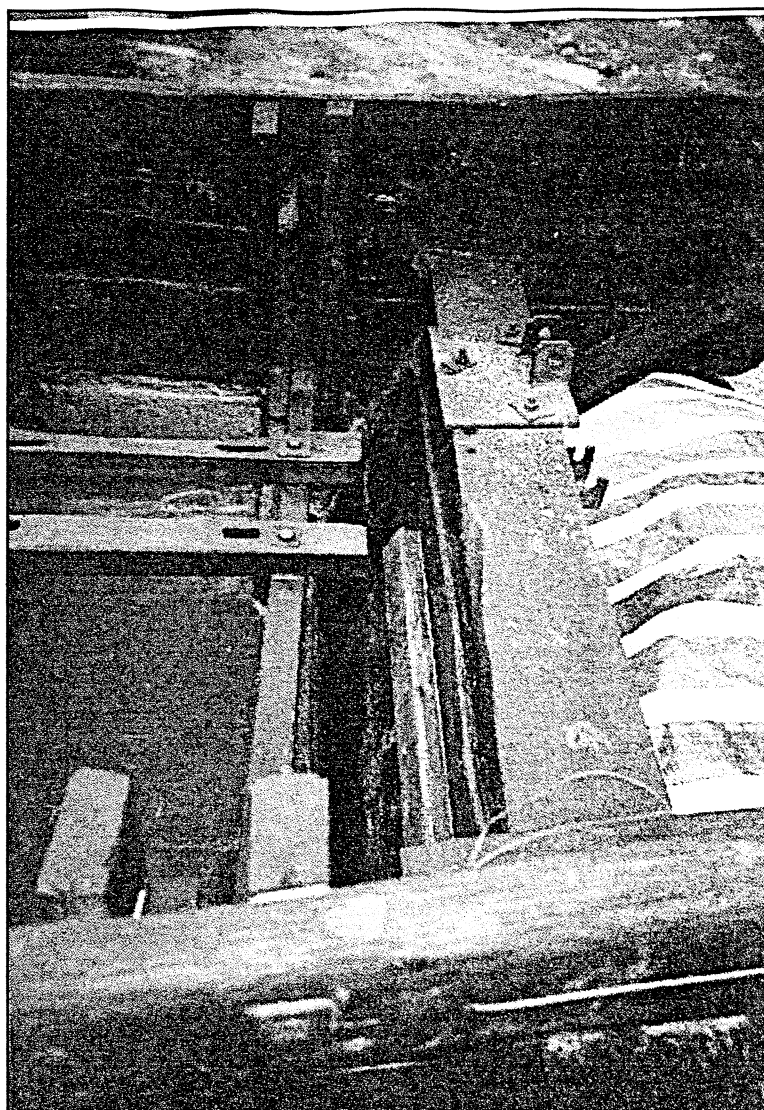
Figure 33. Penetrating Thwart, running along the top edge of the transom and through the side planking of a small boat in Xinwan. This configuration protects the upper edge of the bulkheads, gives rigidity to the thwart, and strengthens the vessel as a whole.

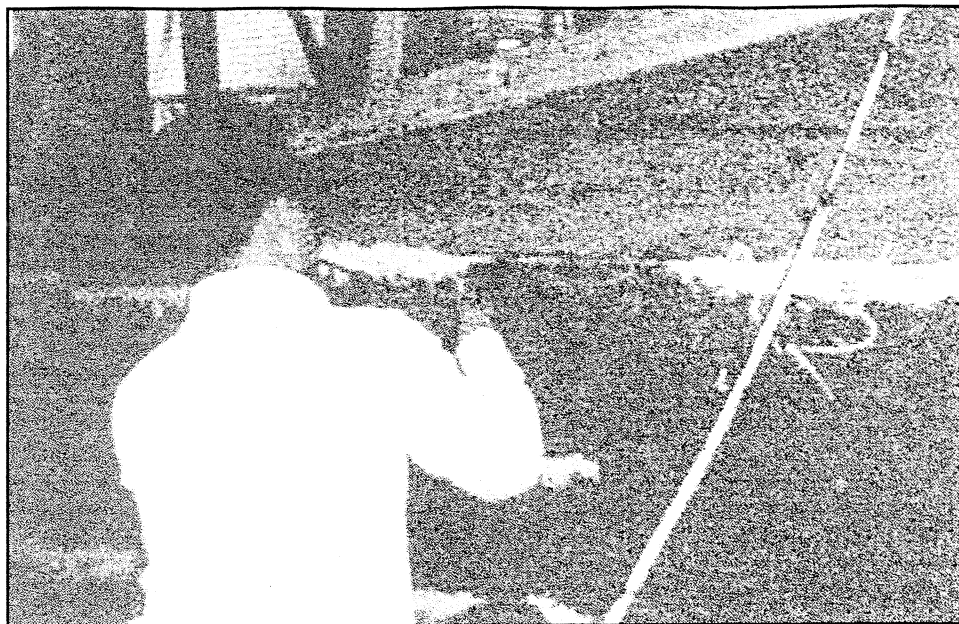
Figure 36. Caulking at Coloane, Macau. A Coloane village shipyard worker presses frayed bamboo fibers into plank seams that have already been beveled and spread with a thin layer of caulking putty. After about ten feet of seams are filled, the caulker will chink the bamboo tightly into the seams, and then fill over this with more of the putty.

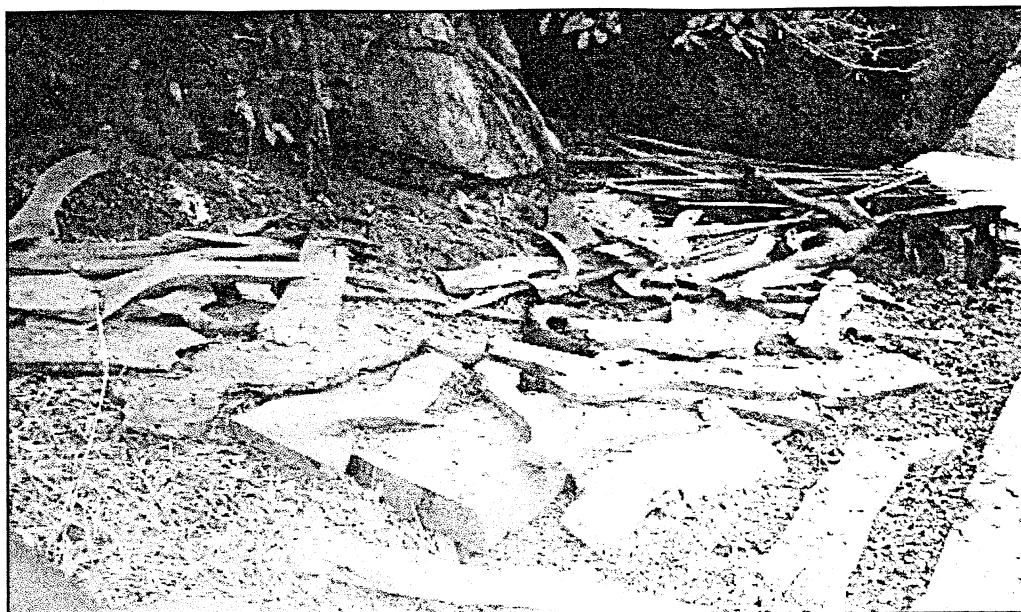
Figure 38. Curved, Grown Timbers at Tanzhou Air-drying in preparation for their use as frames.

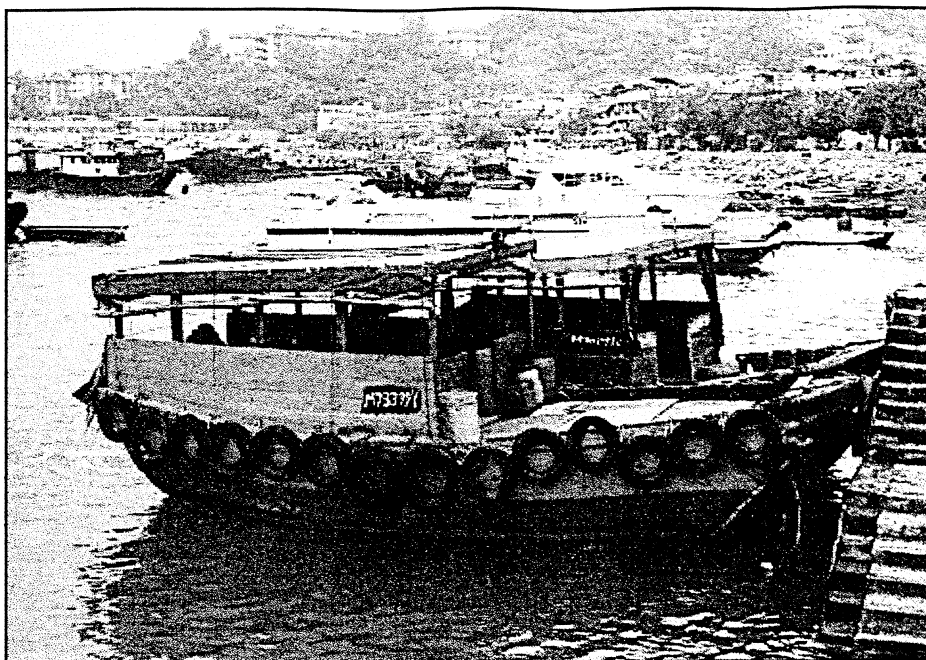
Figure 41. Sampans at Cheung Chau Harbor. Their high freeboard, double-transomed, beamy hull form is typical of sampans in the Hong Kong region, and comes from watercraft traditions of the Tongka peoples.
