The Stavanger Junk Rig Rally 2010

A photo review with some (mostly technical) comments

by Arne Kverneland

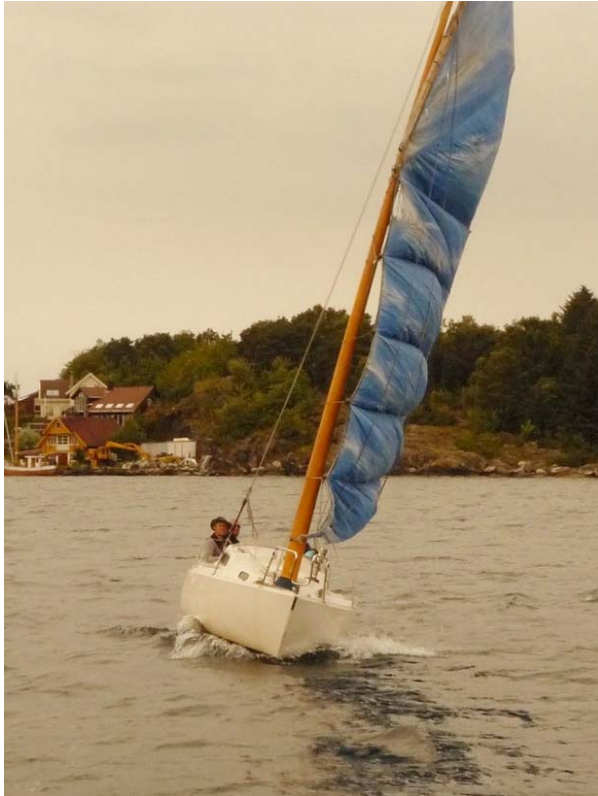
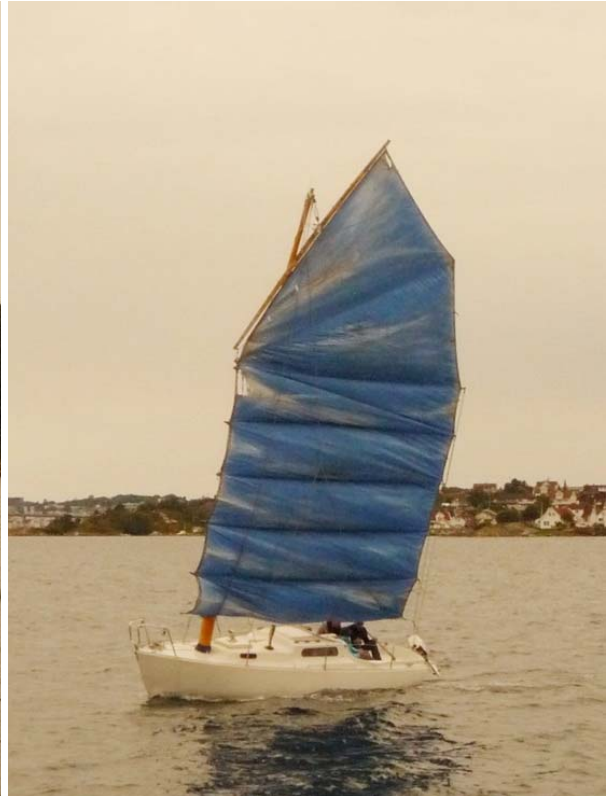
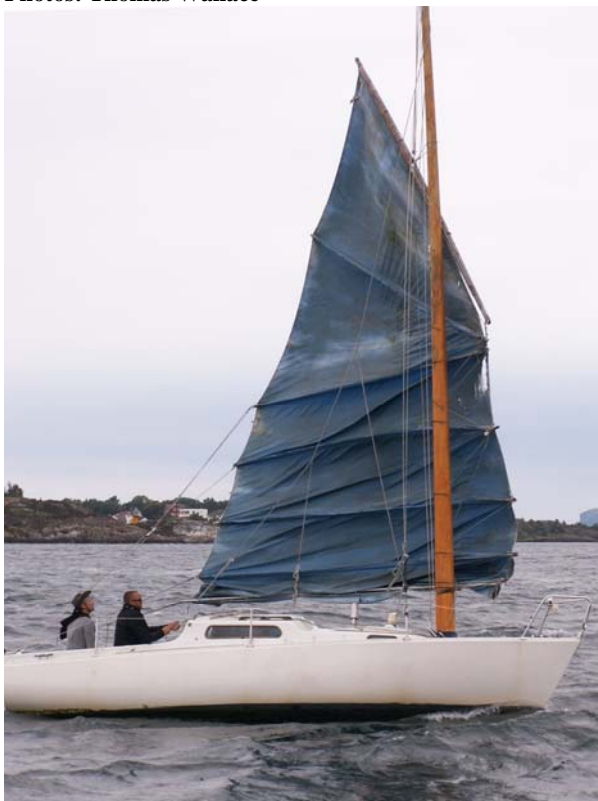
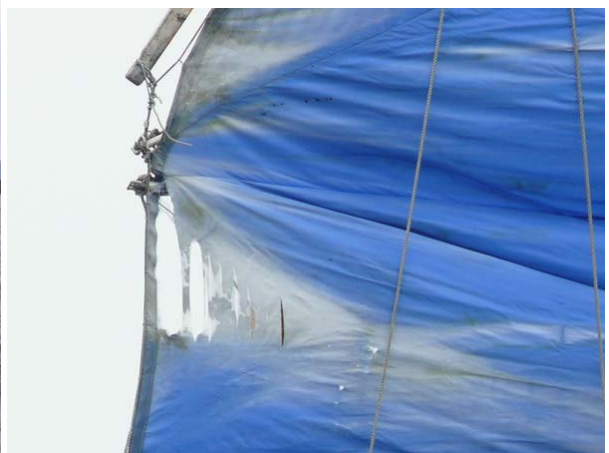
She had been out of use for a while, the present owners being busy with house-building and a baby, so before we started, today's skipper (and last owner), Håvard had to make a dive with a scrape to get rid of most of the biotopes living on her bottom. The photos on next page clearly show that the sail is over-due for being replaced. Still it is worth noticing a few points:

- The camber in the panels has not changed, i.e. the sail has not blown out of shape. This must be because the load in the cloth is so much lower than in an ordinary sail.

- The sail – from 1994 – is now falling apart with big holes in its upper panels. This is partly due to sun-rot and partly due to the fact that sail-ties have not been used for the last years so the fore and aft end of the furled bundle tends to flap in the wind.
- The good news (..in my view...) are that the seams have held up well, both the machine seams along the edges and also those assembling the batten panels and

making the batten pockets. Finally, the hand-stitched boltrope has held up and enabled us to sail the boat even with those big holes in the sail.

- The starboard, coated side is now almost black from mould, while the other side is not nearly as dirty, but is very sun-bleached instead.

- The sunrot is not a big problem. The reason for the holes in *Malena's* sail are only partly caused by the sun; for the last 3-4 years I have noticed that the sail has been left mainly without sail ties on, so in both ends of the sail bundle one can see parts of the sail flapping in the wind. When this goes on day and night for some years, the cloth eventually will have to fall apart...

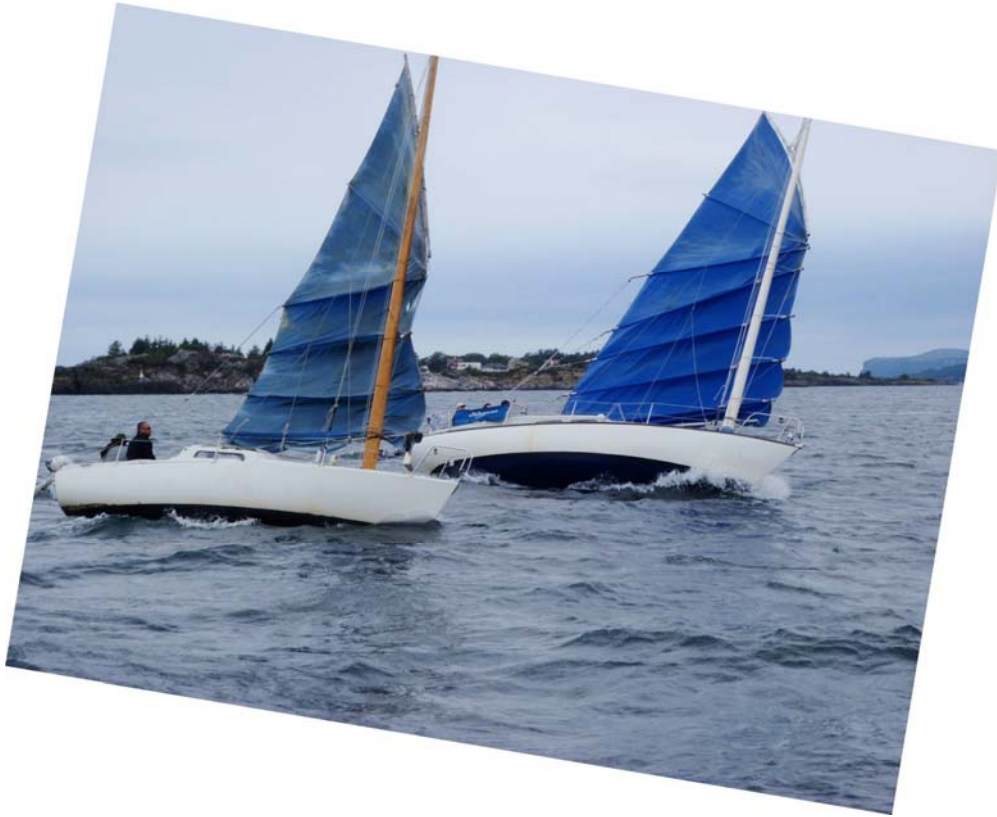
..*Malena and Johanna* together...

A funny thing with these new digital cameras seems to be that the horizons end up listing in all directions. I've spent much time here getting them level. The photo above was a hard case so I had to make a compromise. Note that both *Johanna* and *Malena* are down to 6 and 5 panels in the breeze while the bigger boats mainly kept full sails up. Both *Malena* and

Johanna have big rigs for their weight, but so what? Reefing can be done in seconds anyway.

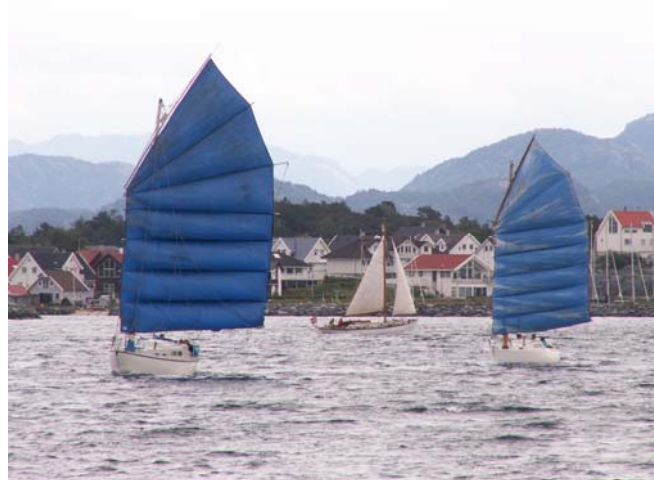
..downwind and with the breeze easing, the sails go fully up again...

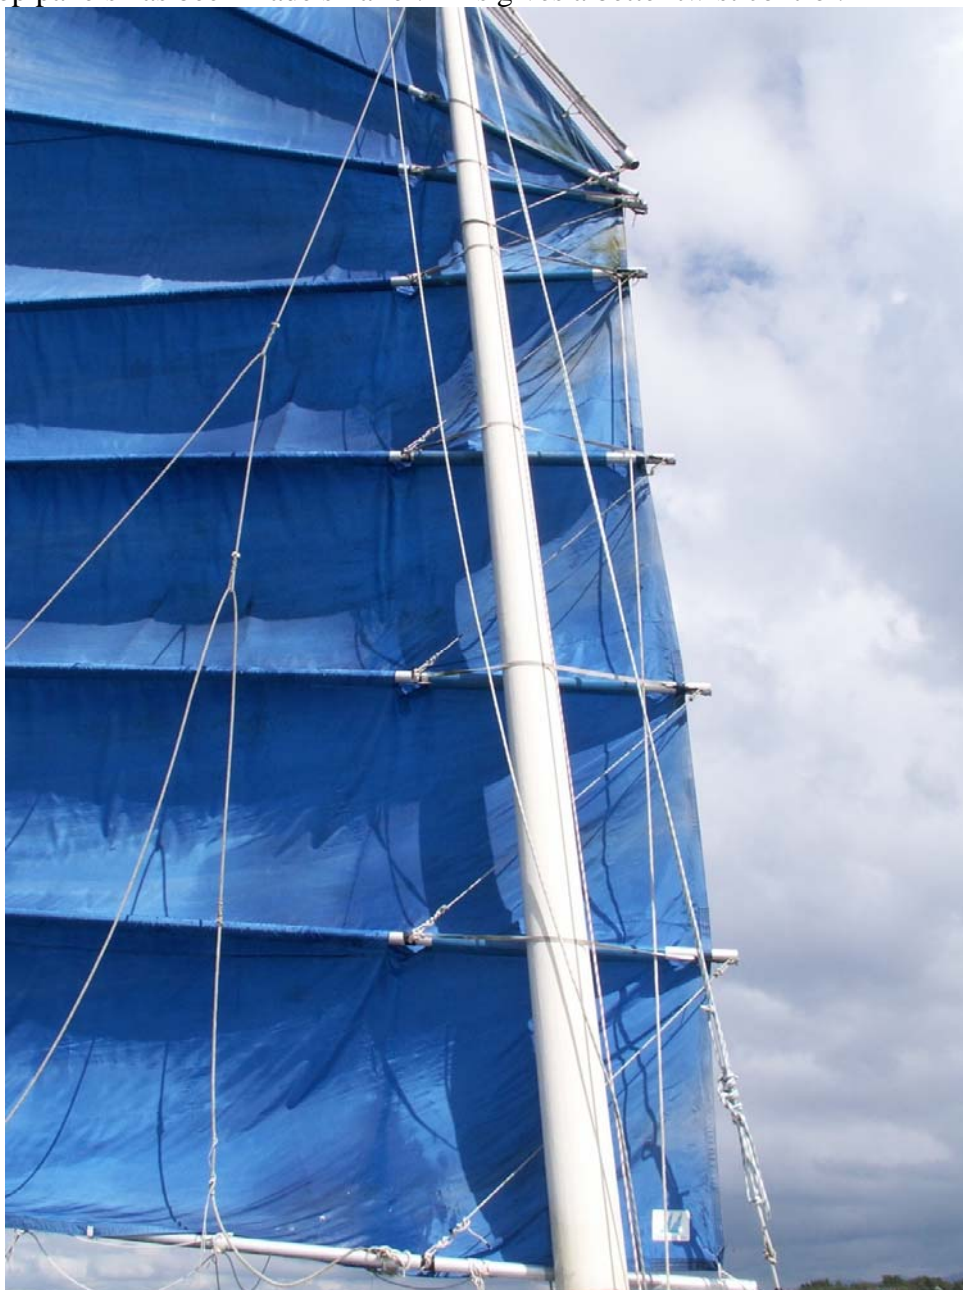
..Johanna's sail; here the starboard side is the un-coated one...

I enlarged the photo above a little to let you spot some details:

- Note that the luff hauling parrel now just acts on the yard and batten no. 3. To keep the rest of the luff straight I mainly rely on gravity. Here with a full sail set, the elastic tack line helps, but when reefed there is no down-haul to stretch the luff. To get away

without downhauls one need to keep the batten distance moderate and the battens shouldn't be too light either. Some scalloping of the luffs will still show, but doesn't seem to affect performance.

- The Hong Kong parrels (those diagonal lines behind the mast) are essential to avoid big camber-robbing diagonal creases. They must not be too steep, or they will tend to pull the battens together.
- The batten parrels of 20mm webbing. They are kind to the mast, but more important; when hoisting the sail they are less prone to catching each other than the rope type.
- *Johanna's* sail too tends to get a lot of dark spots of mould now (on the port side). The problem with this cloth is that the doped side is sticky so collects dirt which rapidly leads to mould. The decay process is faster on *Malena* and *Johanna* which don't use sail cover, but even on *Samson's* sail which is regularly covered, one can see signs of the problem.

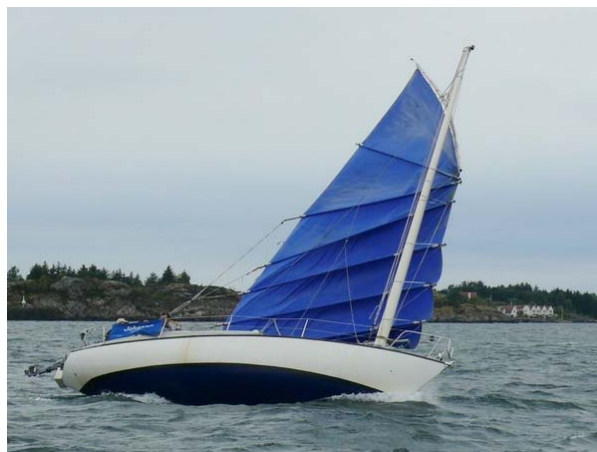
There were plenty of chances of getting photos like these early on Saturday and several ended up with variations of these shots. Note how *Johanna* can lean over seriously without getting nose-heavy. This shows a boat with well balanced ends, making helming easy work. In fact, on Sunday afternoon, on our farewell sail together with *Peregrine*, we sailed out the whole Åmøy-fjord with the tiller locked (2-3Nm).

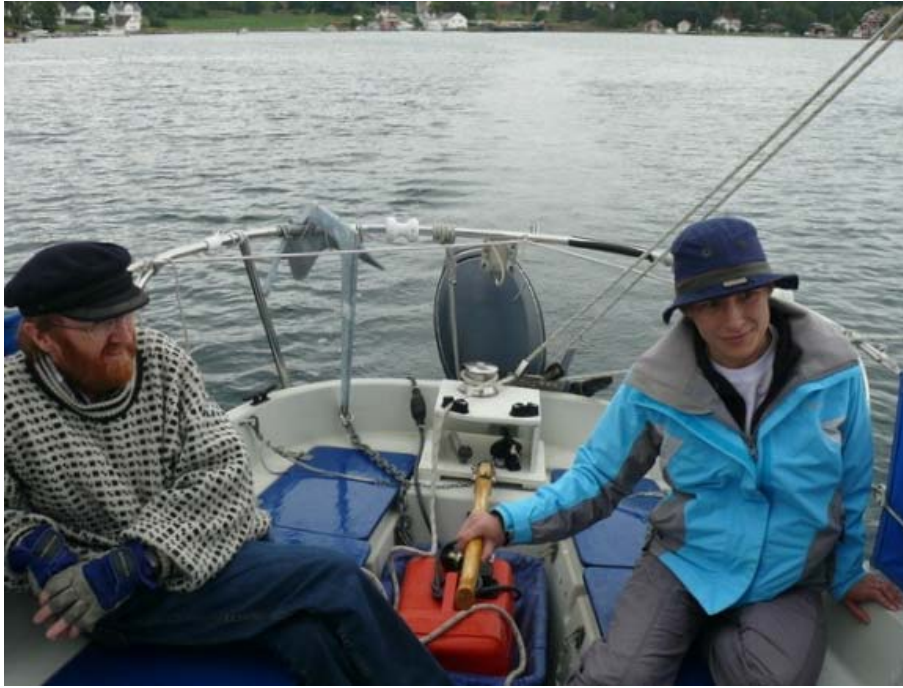
.. Sunday morning, Louise taking the helm in an F2 – F3 ...

The very fresh anti-fouling paid off here; *Johanna* just went like magic. Note the carefully positioned snubbing winch and cleats for the sheet, making sheeting that big sail easier. I only use 3-part sheet to save clutter in the cockpit and friction when hoisting the sail. Also note the only 10-days-old paint job on the cockpit hatches!

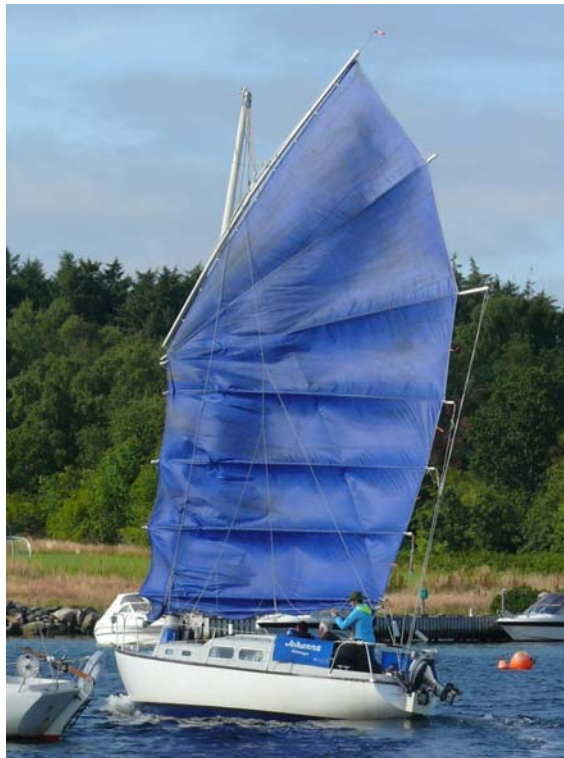
.. *Johanna* rounding up to drop sail after the last sail in this rally, Sunday afternoon...

On the port side the top panels are more black with blue spots than the other way around. See the conclusion on that matter.

- All the mildew that has collected on the blue sails shows that one should avoid this sort of coated canvas for sailmaking. The coating is a bit sticky and attracts dirt which attracts moisture – which again soon starts producing mildew. Even *Samson's* sails which have been carefully covered between sails, now show traces of it.

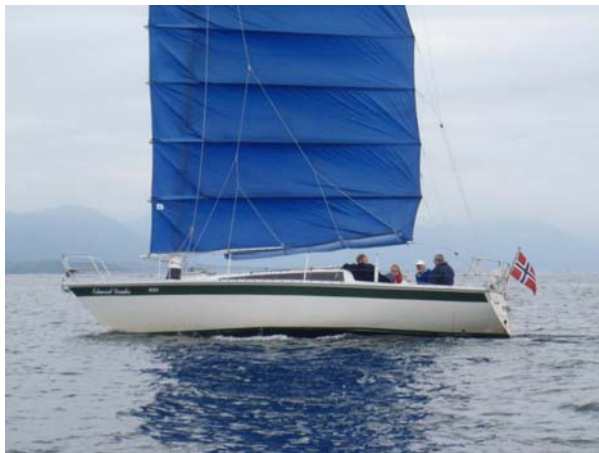
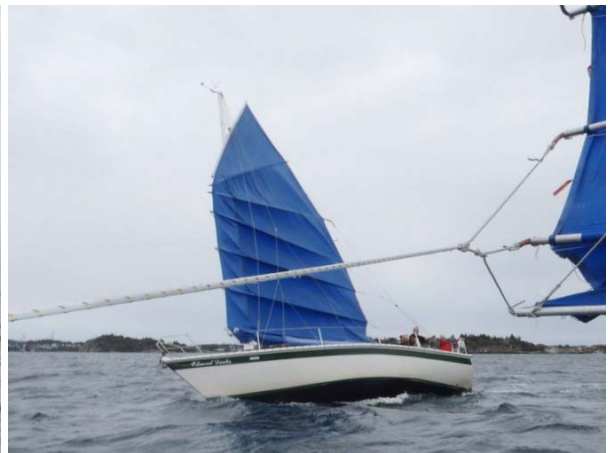
Edmond Dantes, Ketil Greve's boat is a typical all rounder, doing well in light winds and doing superbly well in a blow. Her sail from 2006 is mostly resting under a good sail cover so seems not to suffer from mildew (..yet...).

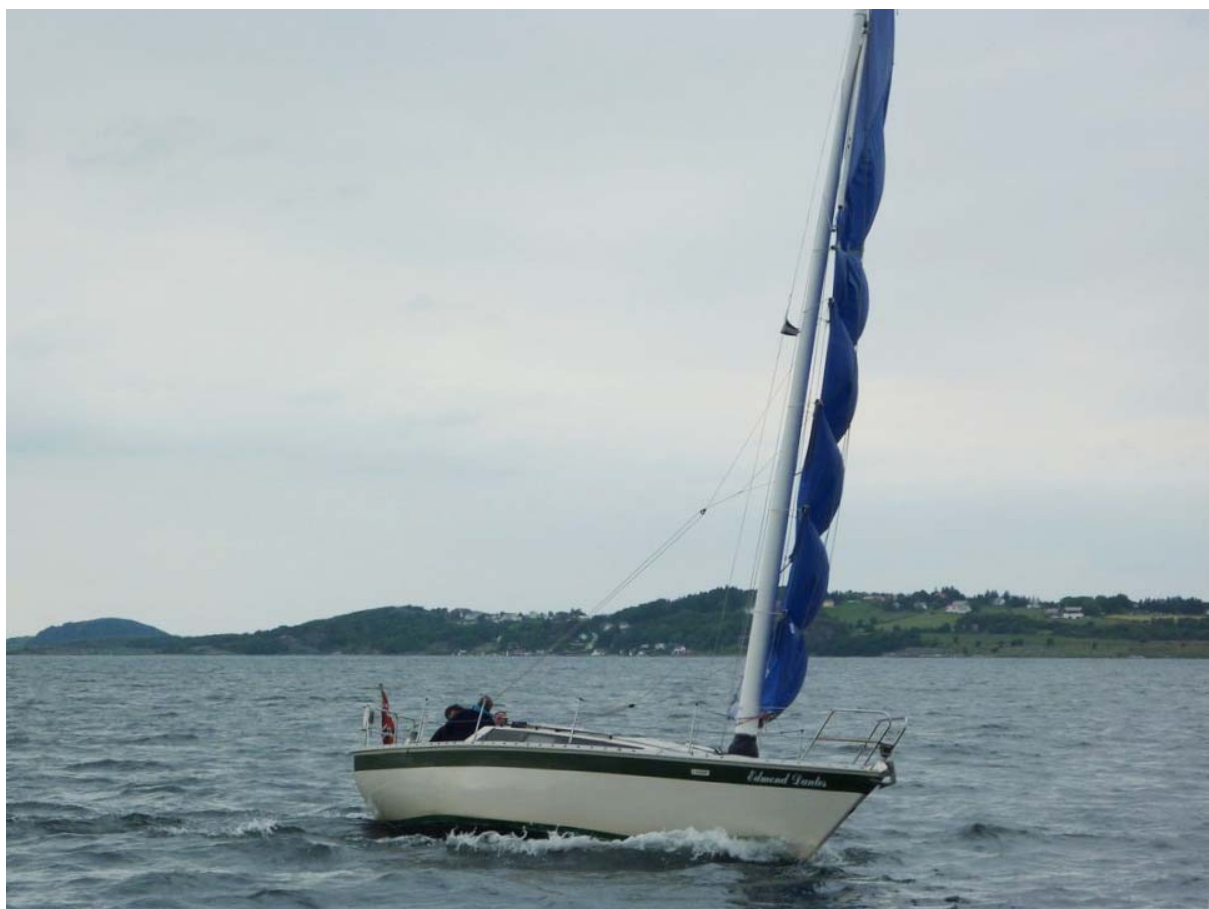
...another view of the bagginess one gets when using the barrel cut method to produce camber.
Right or wrong; it makes the boat move...

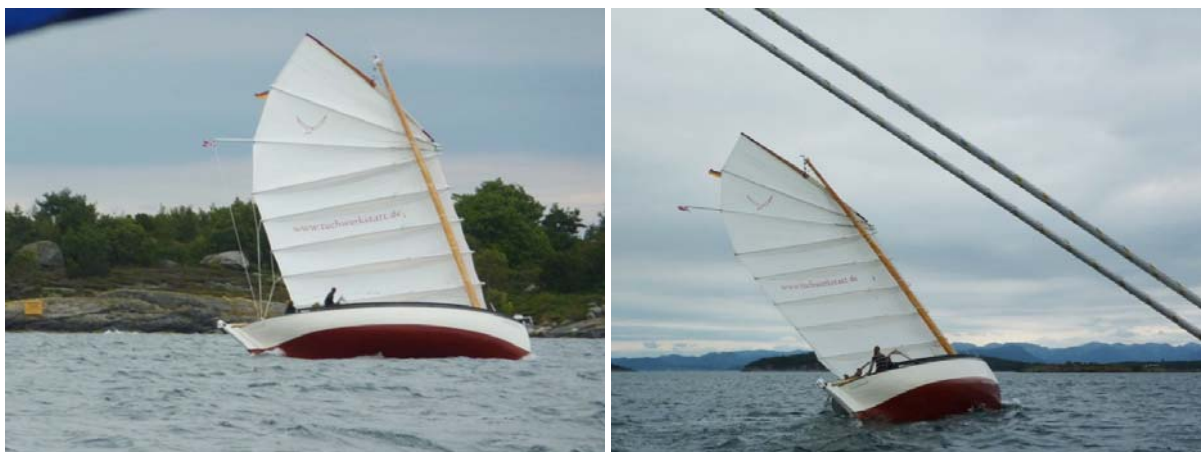
Peregrine was often seen leaning over like this, but she seemed to like it. Just as with *Johanna* her hull is well balanced so she doesn't develop much weather helm in the process.

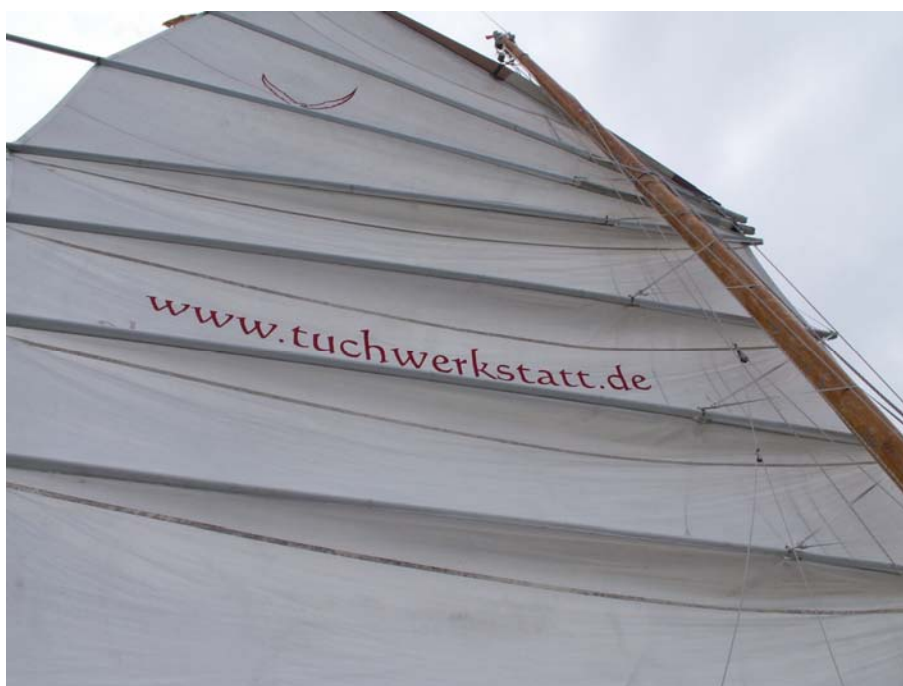
Peregrine's Dacron sail

The sail is made from ordinary polyester sail cloth, not the soft nylon as used in the blue sails, but as the photo above shows, the barrel-cut cambered panels set pretty well none the less.

- *Peregrine's* sail, made from ordinary polyester sail cloth has proven that the cambered panel sail (barrel cut) can be produced from quite stiff cloth; stretchy nylon is not needed to achieve the camber.

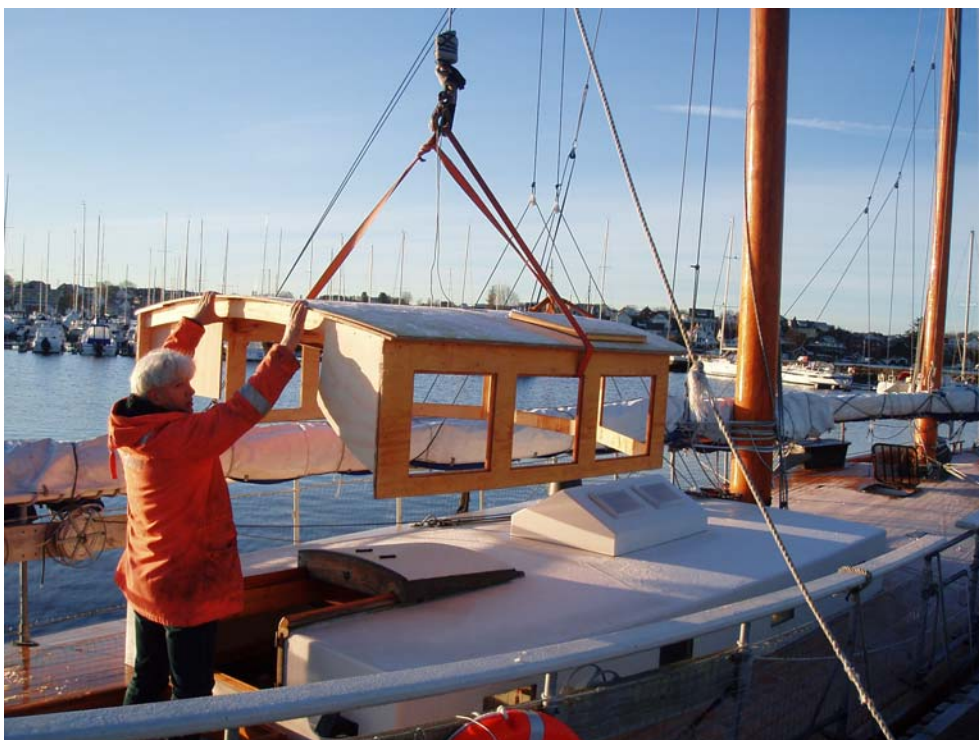
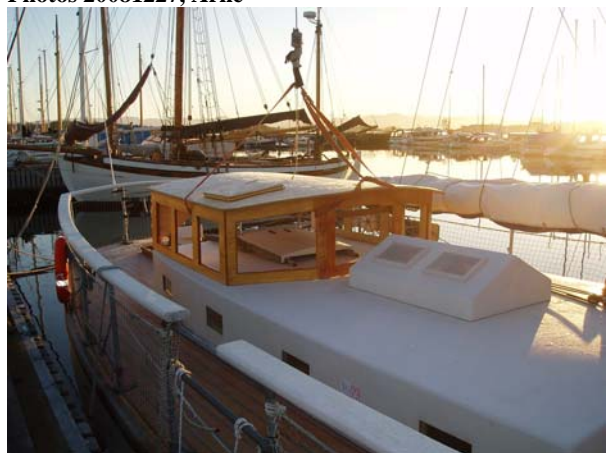
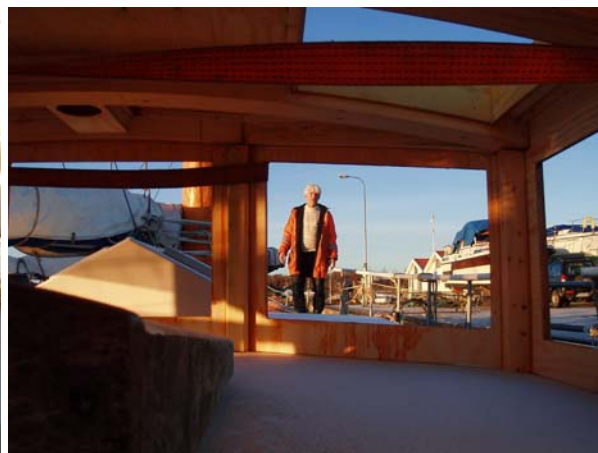
.. about to trial fit the new pilot house...

After the JRA rally in 2008, Svein Magnus found that sitting out in the breeze all day long can be a bit chilly, particularly for idle crew/passengers. He set to work on making a pilot house to provide some shelter and still retain all-round view.

The test fitting proved so good, both from the outside and inside that he went on and soon finished it. The high sky-light also had to give way for a lower one (below)

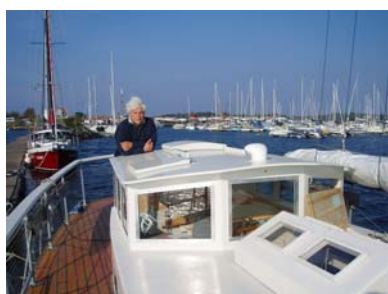
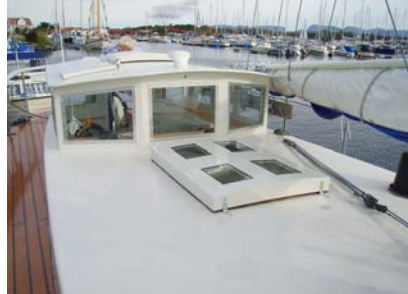
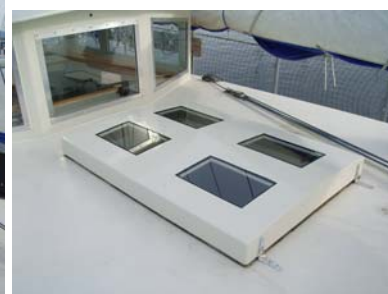
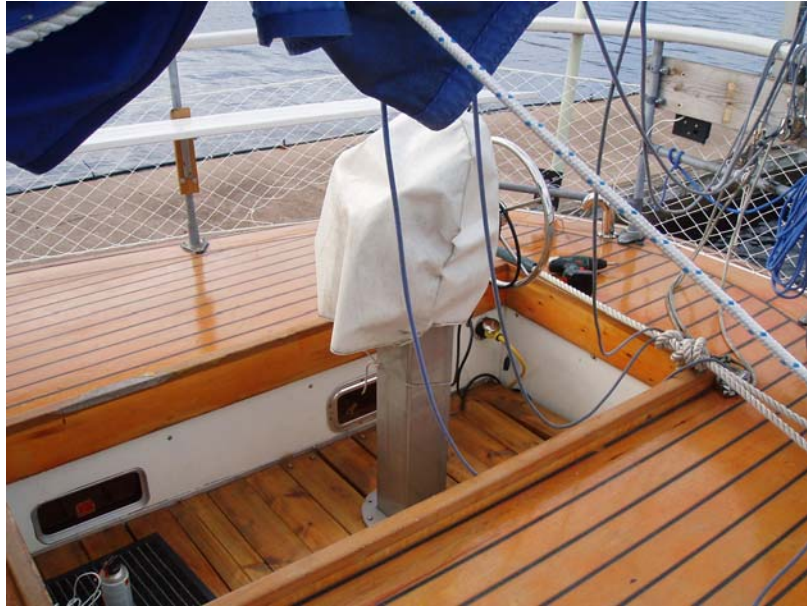
...and on these, taken in 20091009 the new low skylight can be seen...

The cockpit has had the floor raised, the wheel has been replaced with a smaller one and also moved forward a bit.

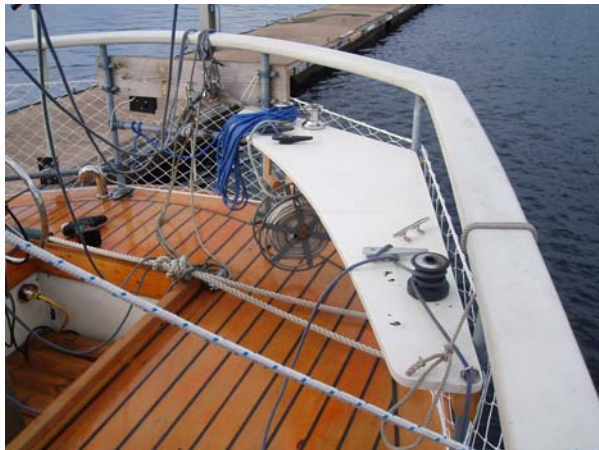
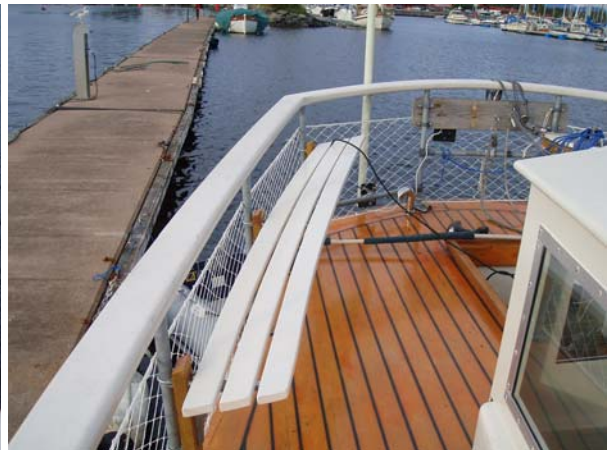
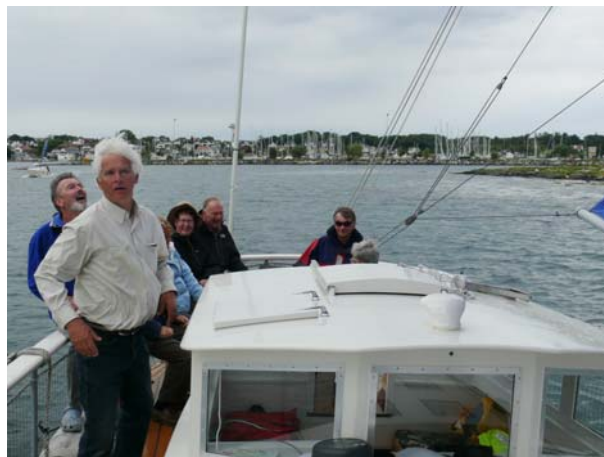
On the port side Svein has fitted a sturdy table/bench which takes the two winches for the main sheet and the winch for the new central foresail sheet. On the starboard side he simply fitted a “park bench”.

The pilot house saw little use during this rally, but the benches soon got popular...

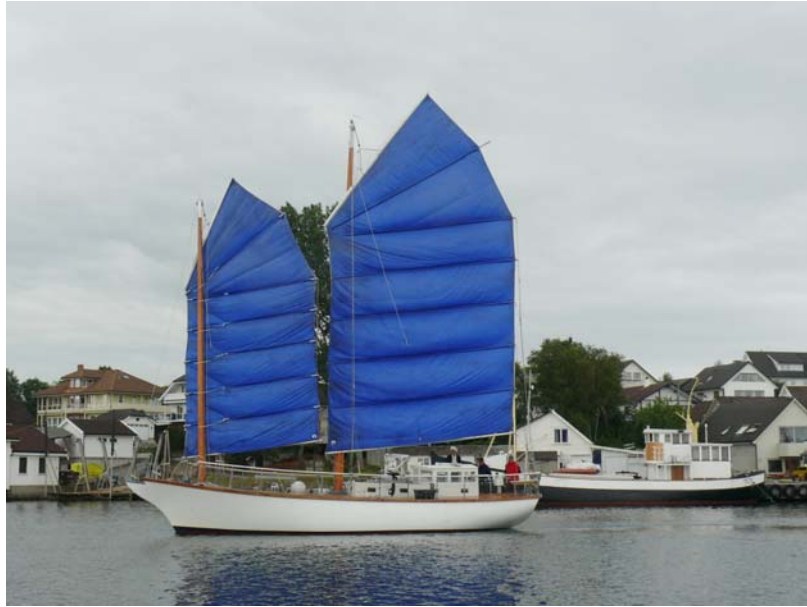
..a final shot of *Samson*, having just got up the sails on Sunday morning...
